**Maguire Iron, Inc.**

# MANAGING ANTENNAS ON WATER TOWERS

# Antennas on Water Tanks

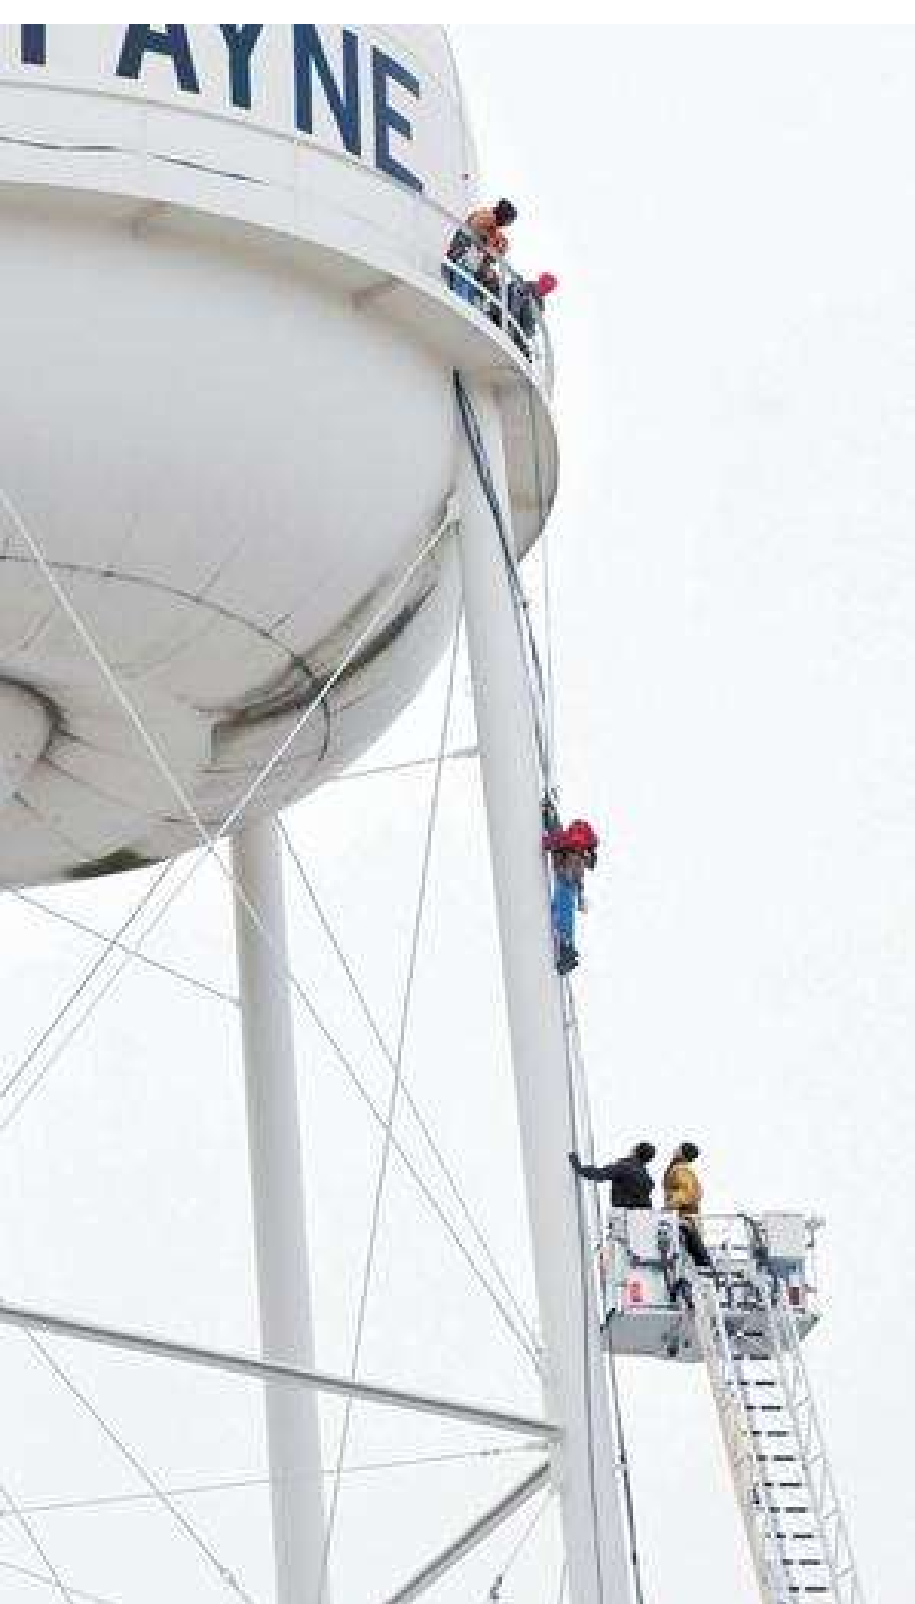
Antenna Installer  
Rigging Failed!

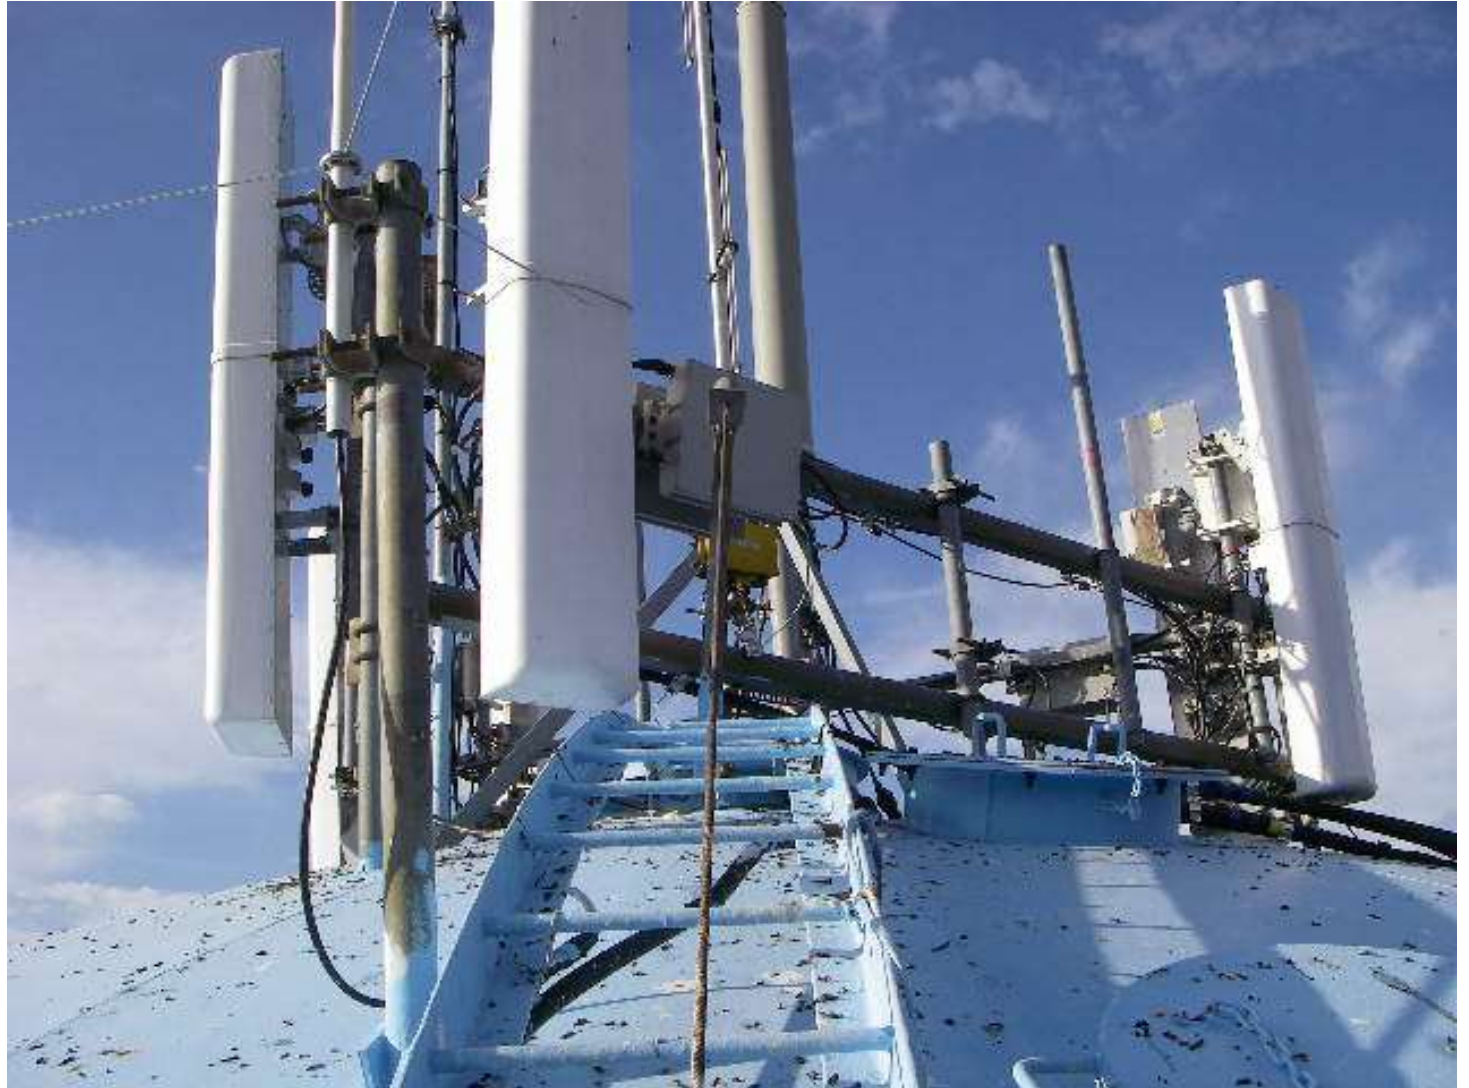
# Antenna installed over roof ladder

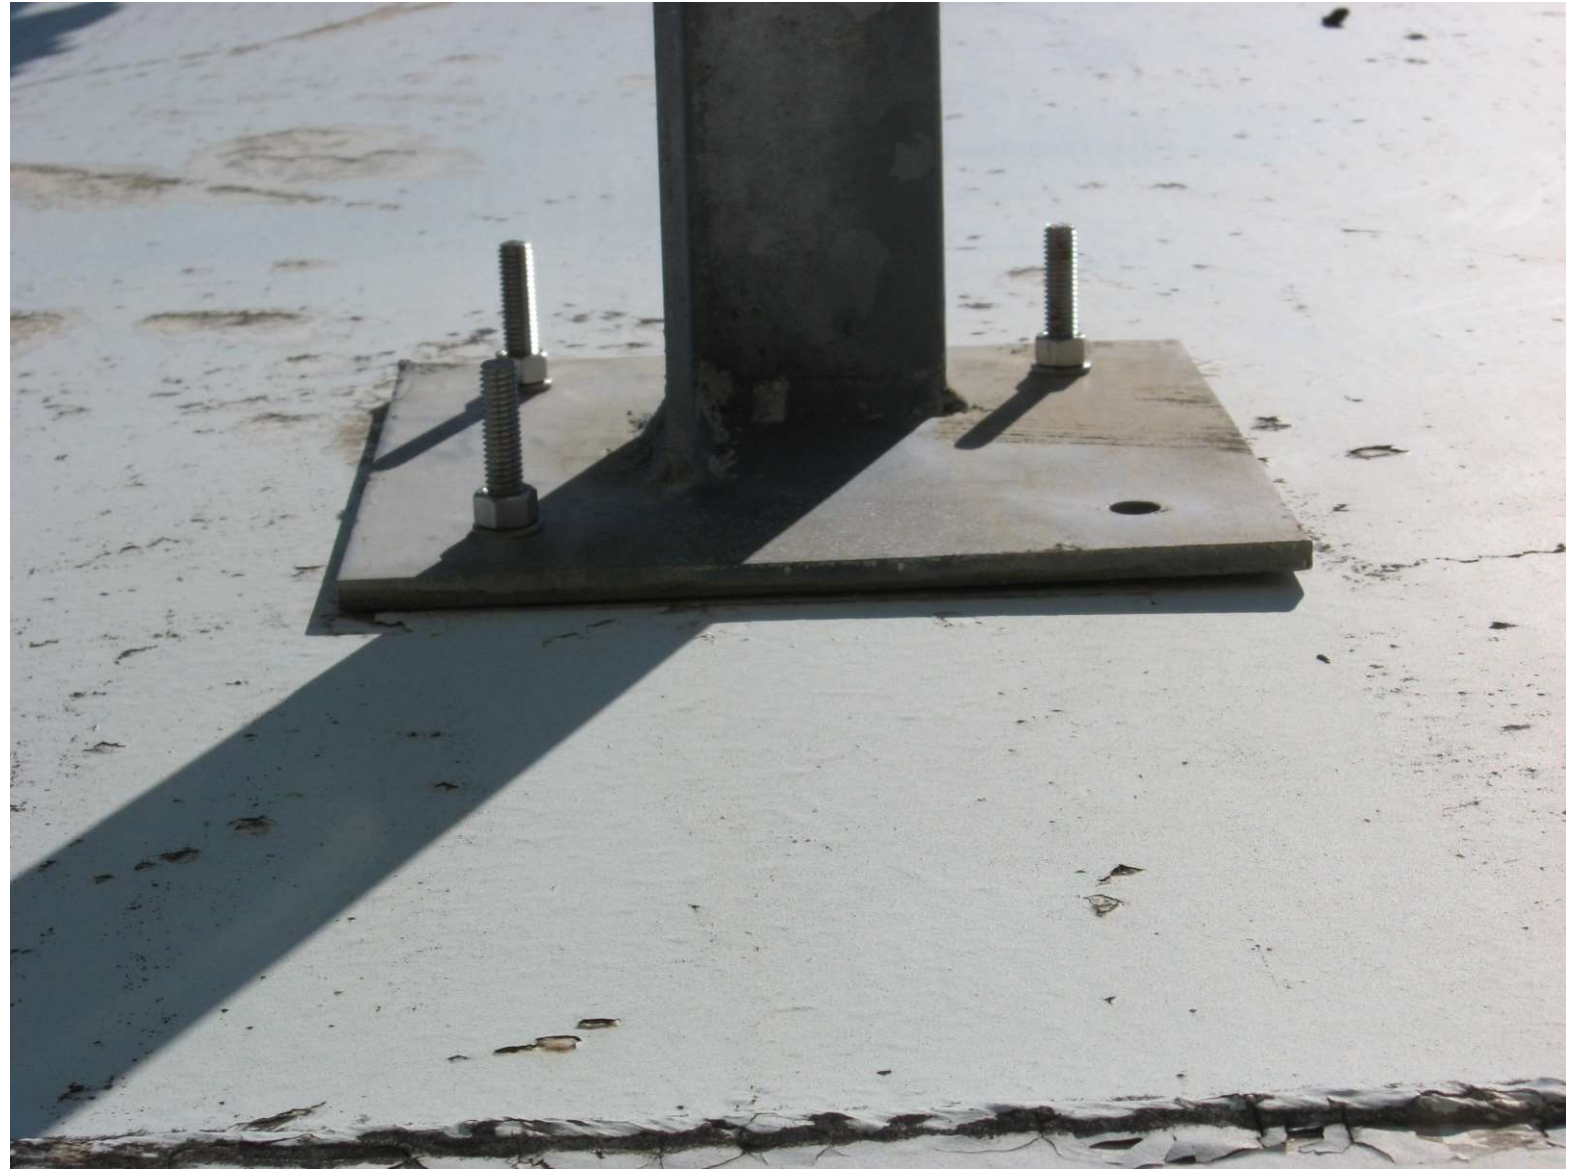
# Poor Installations

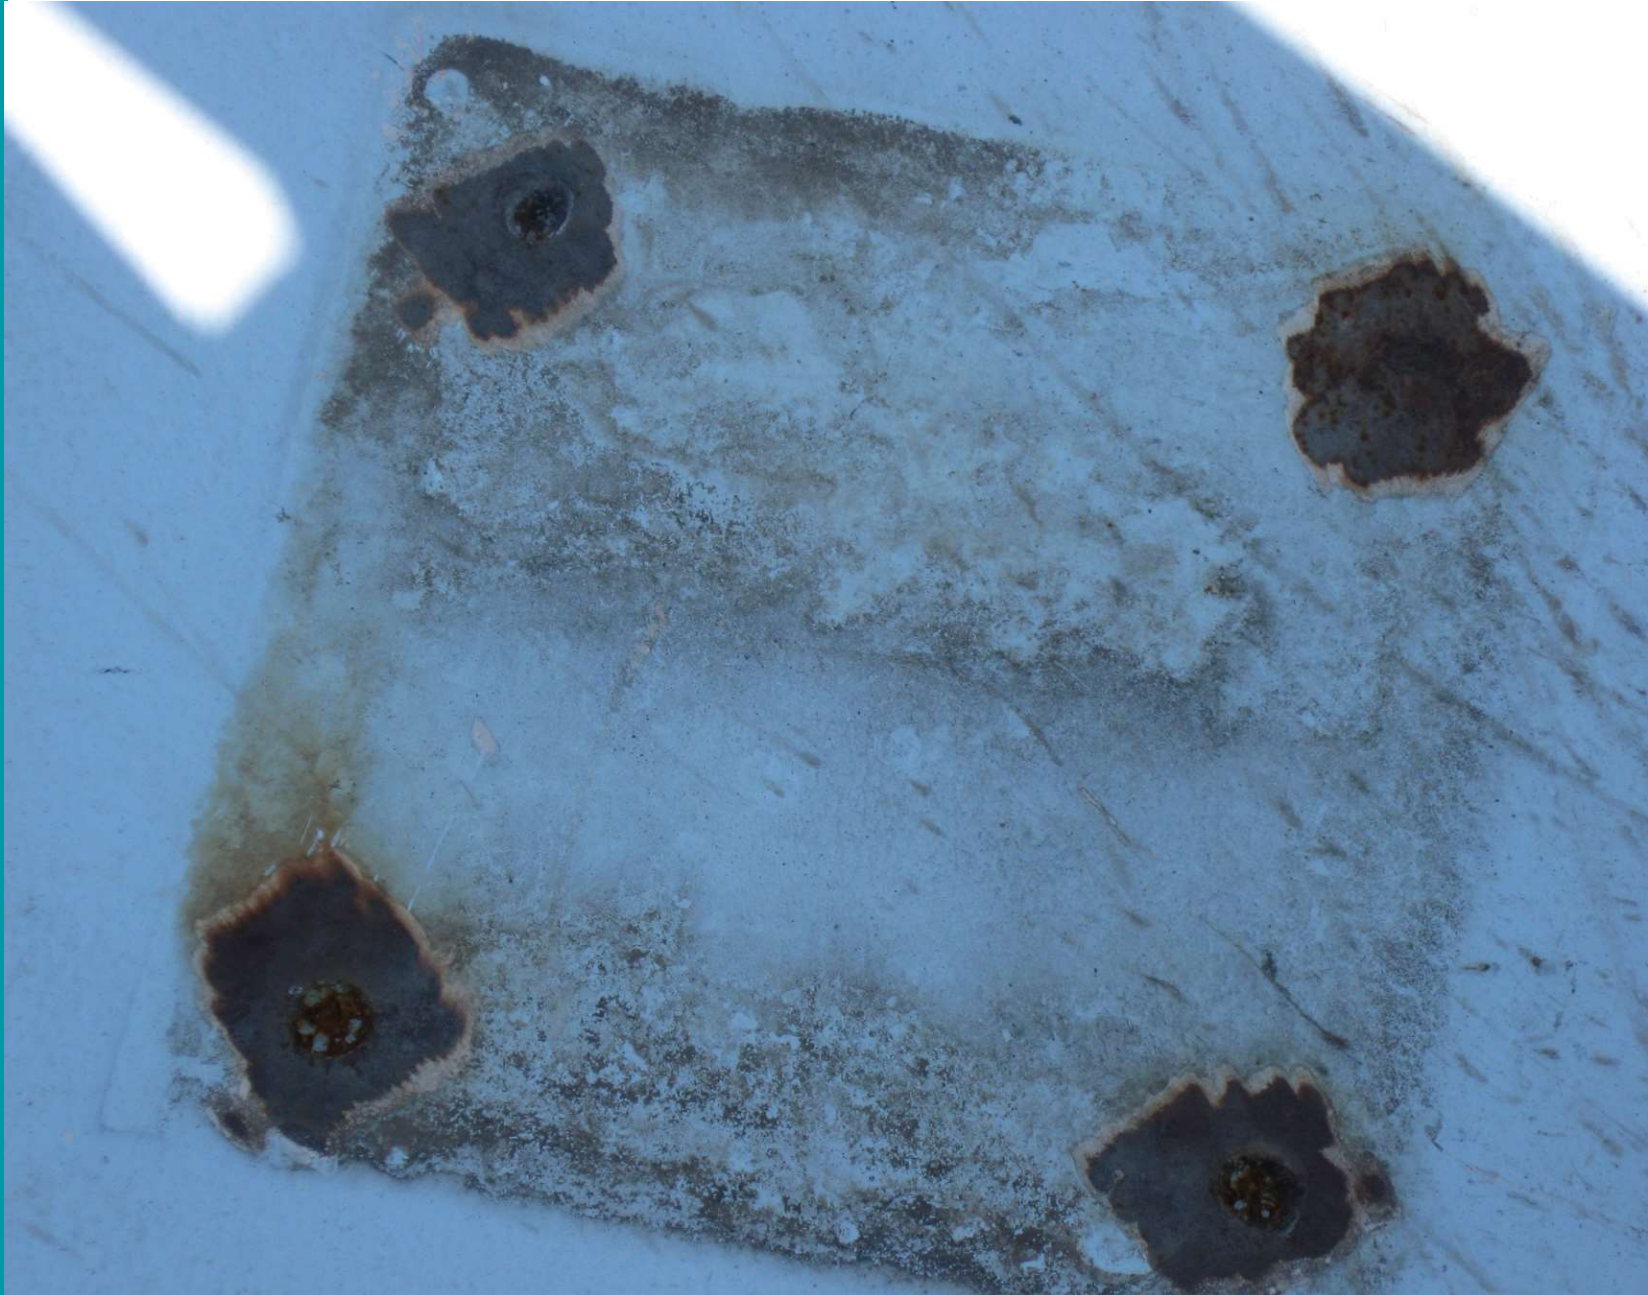
# “STUD” WELDING

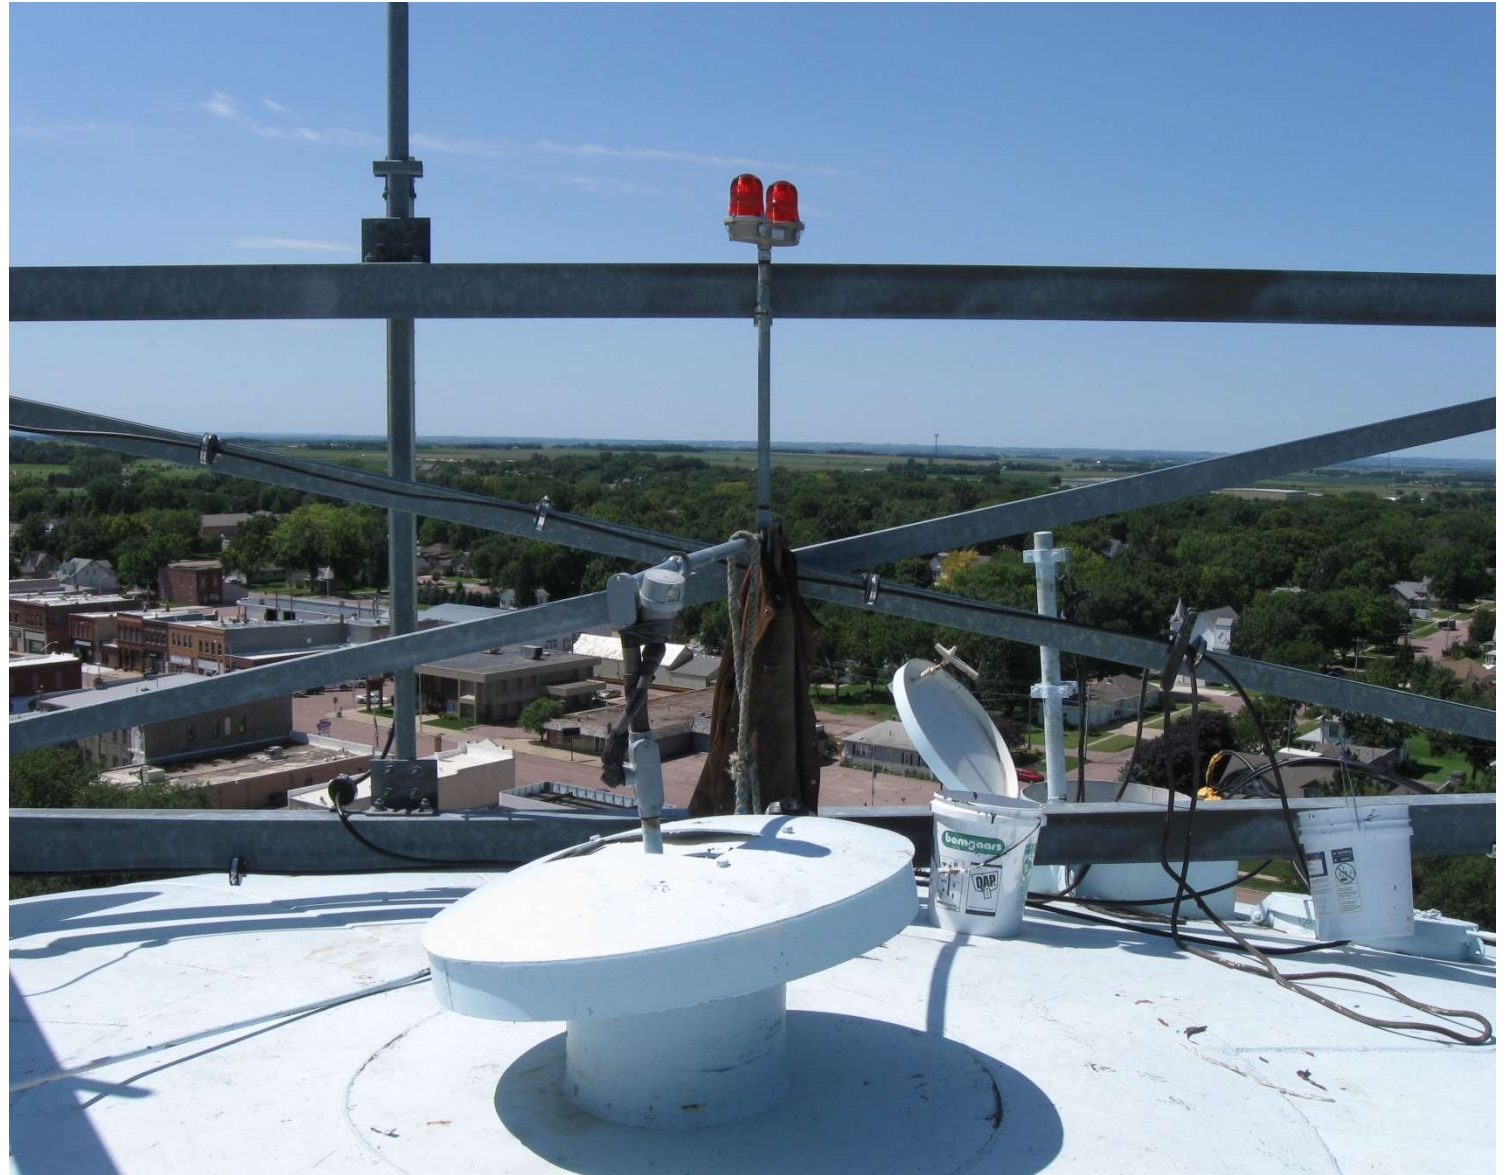
# Repairs of Existing Corral

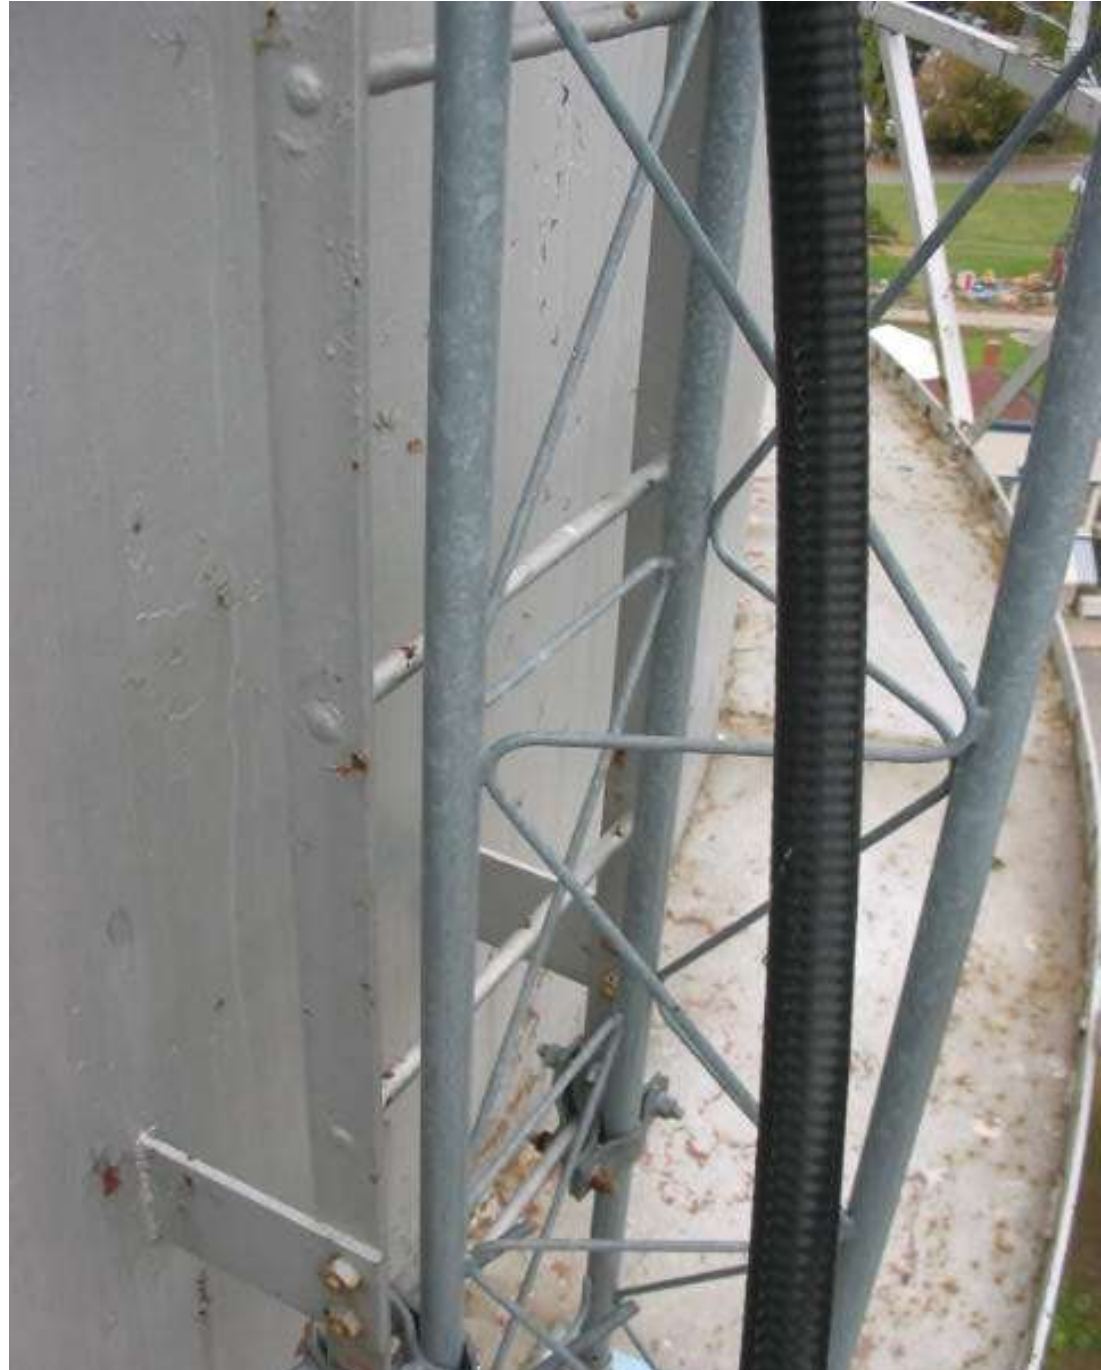
# Blocked Shell Ladder

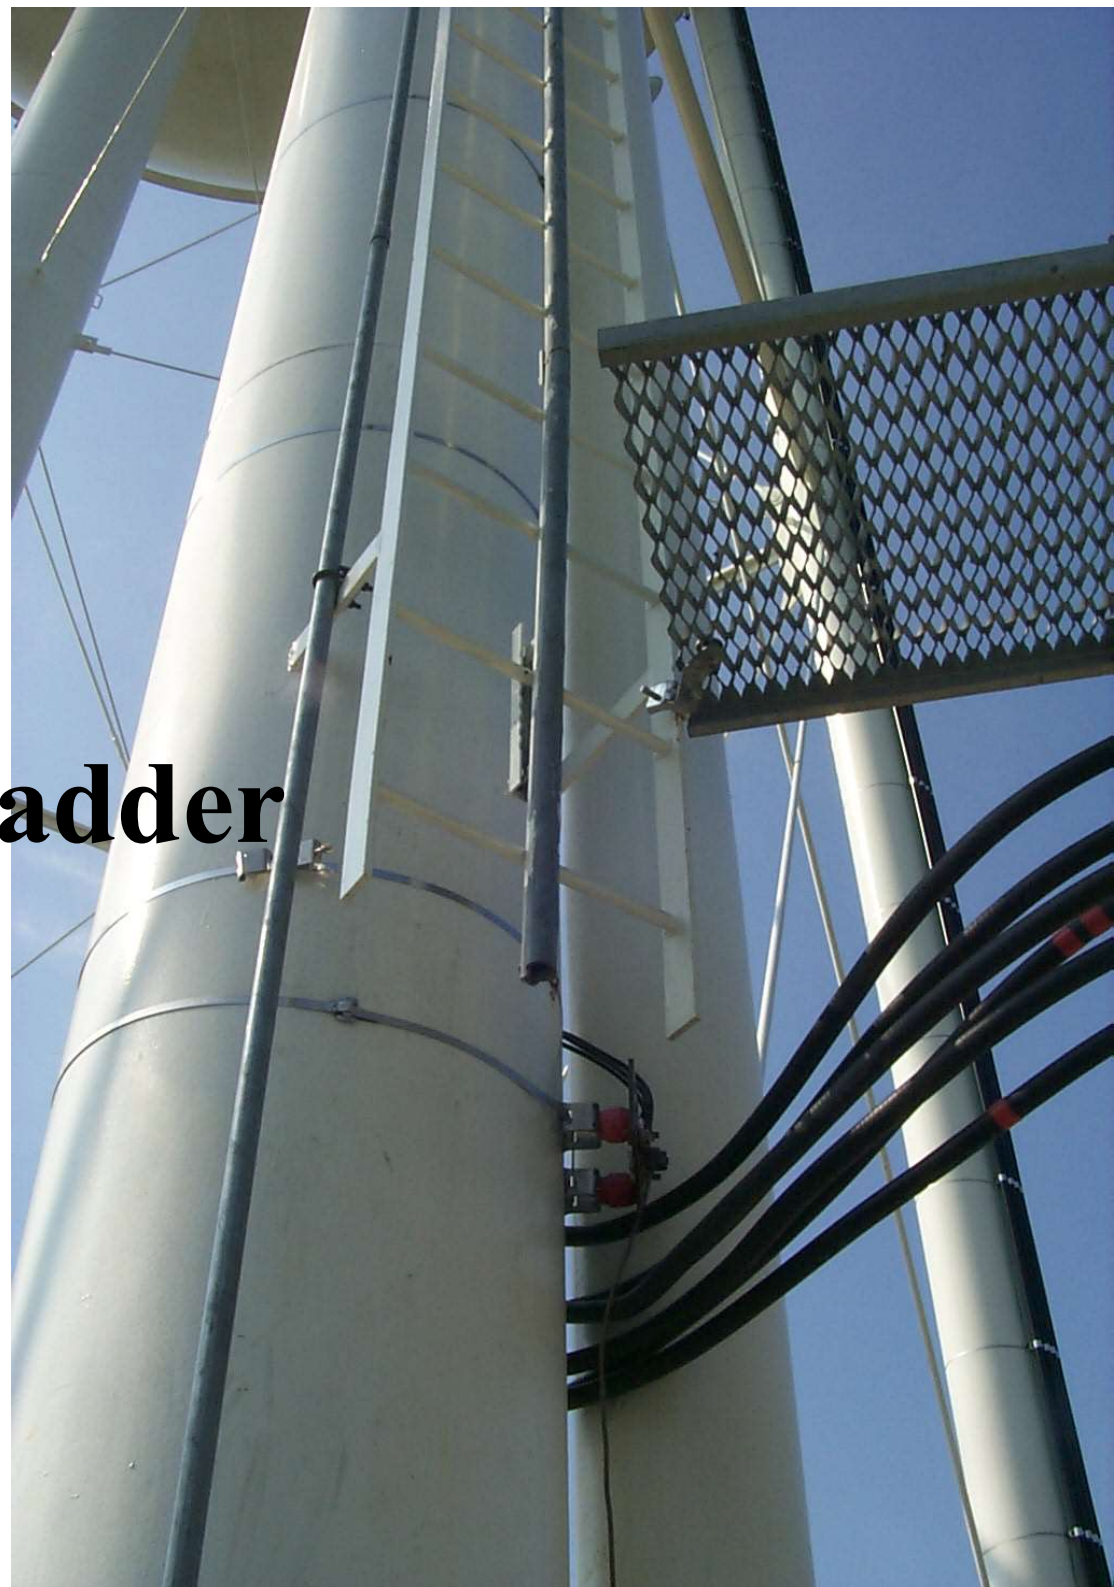
# Blocked Ladder

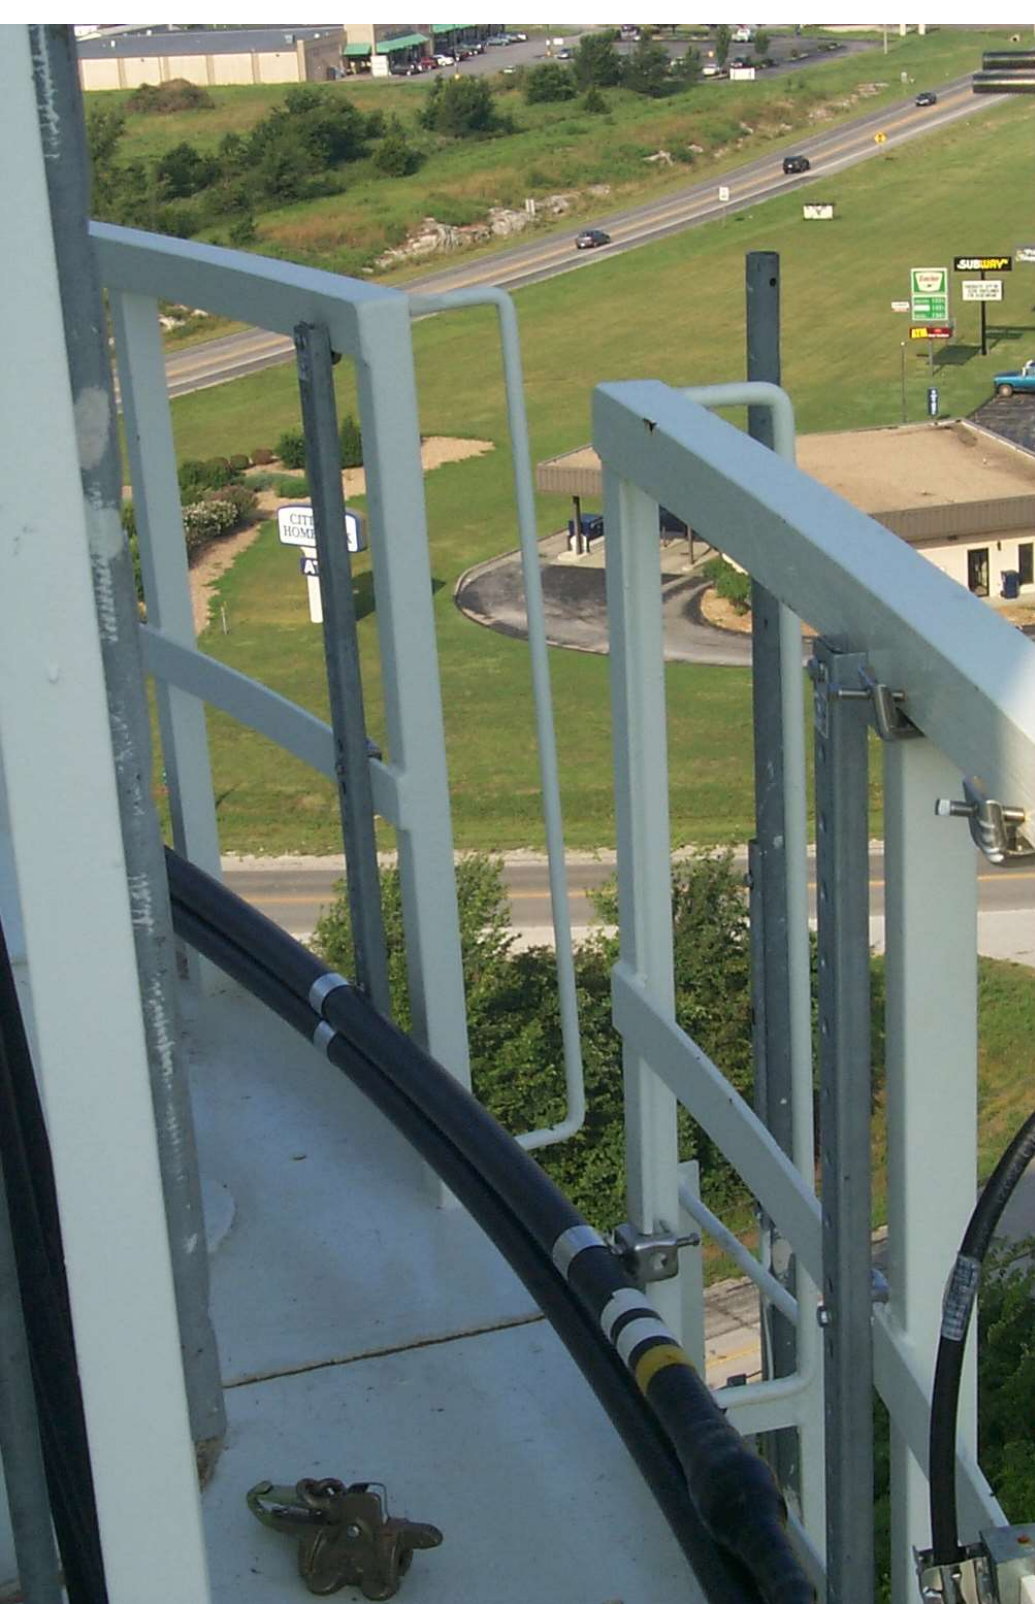
# **Trip Hazards**

**Balcony blocked by cables**

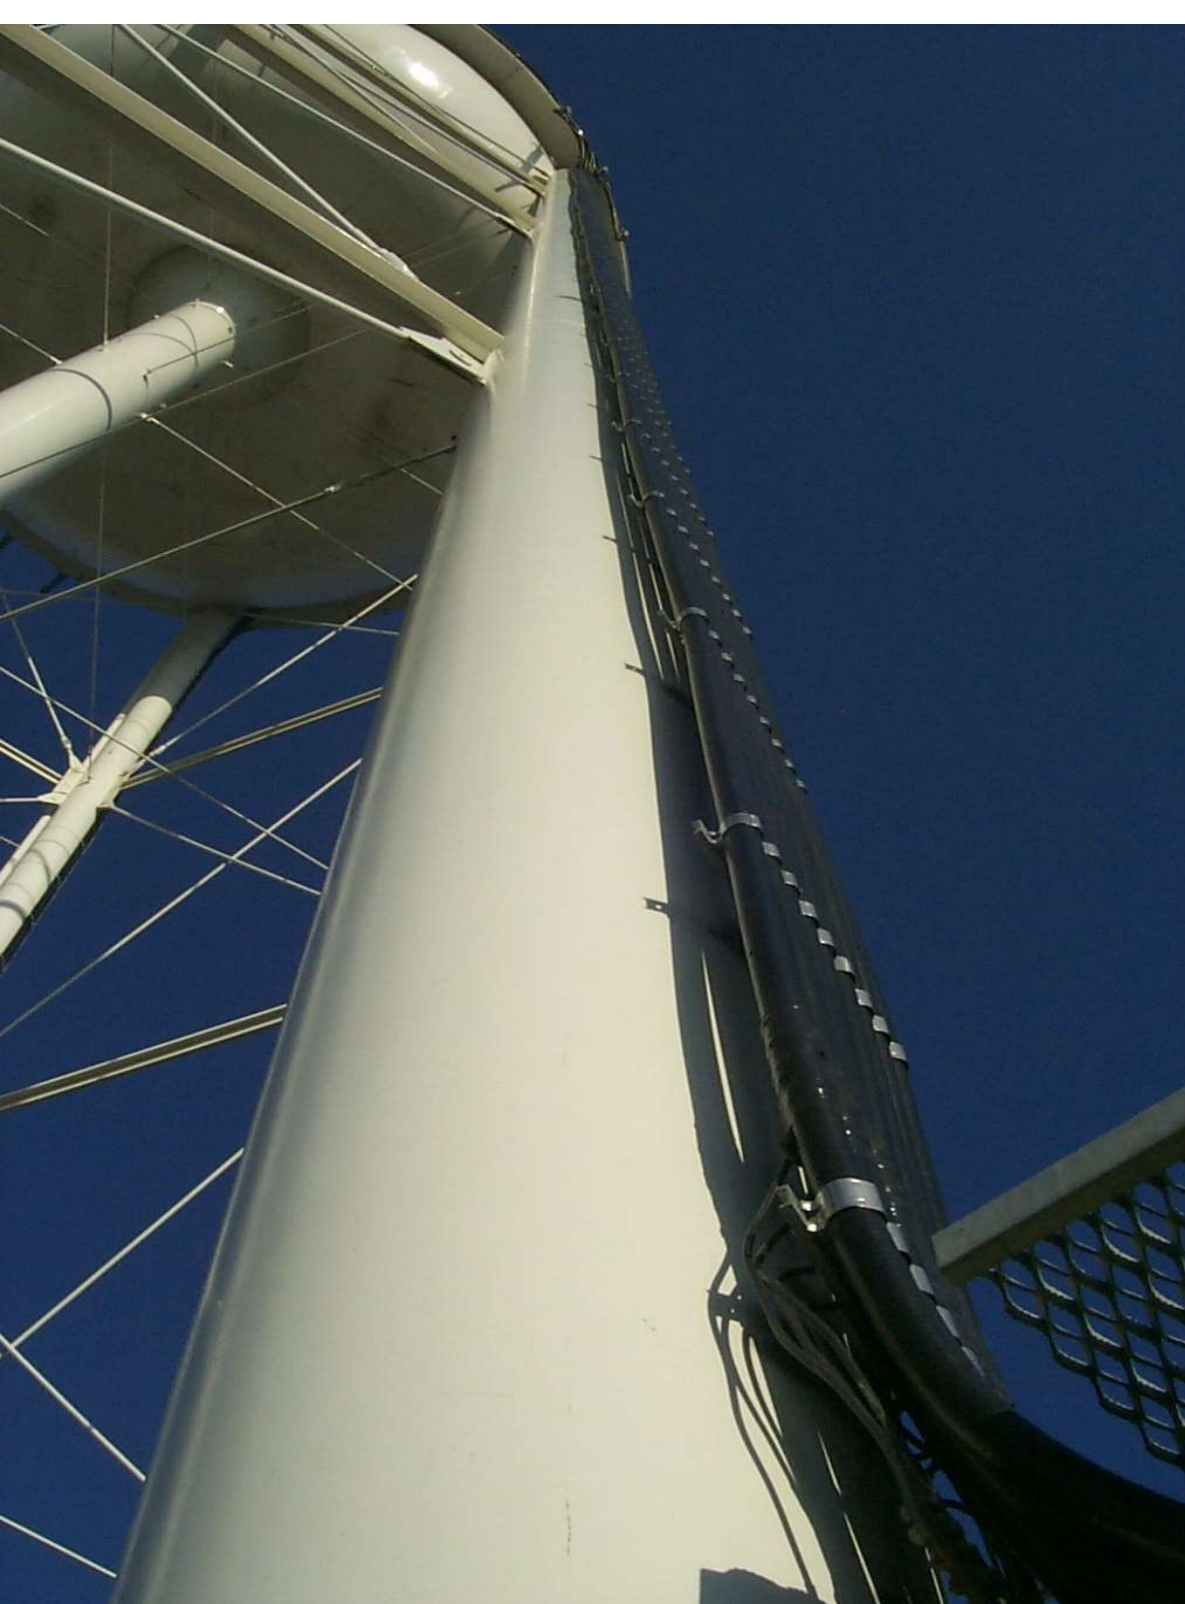
Maintenance Issues

**Coax Cables  
Attached to  
Tower leg**

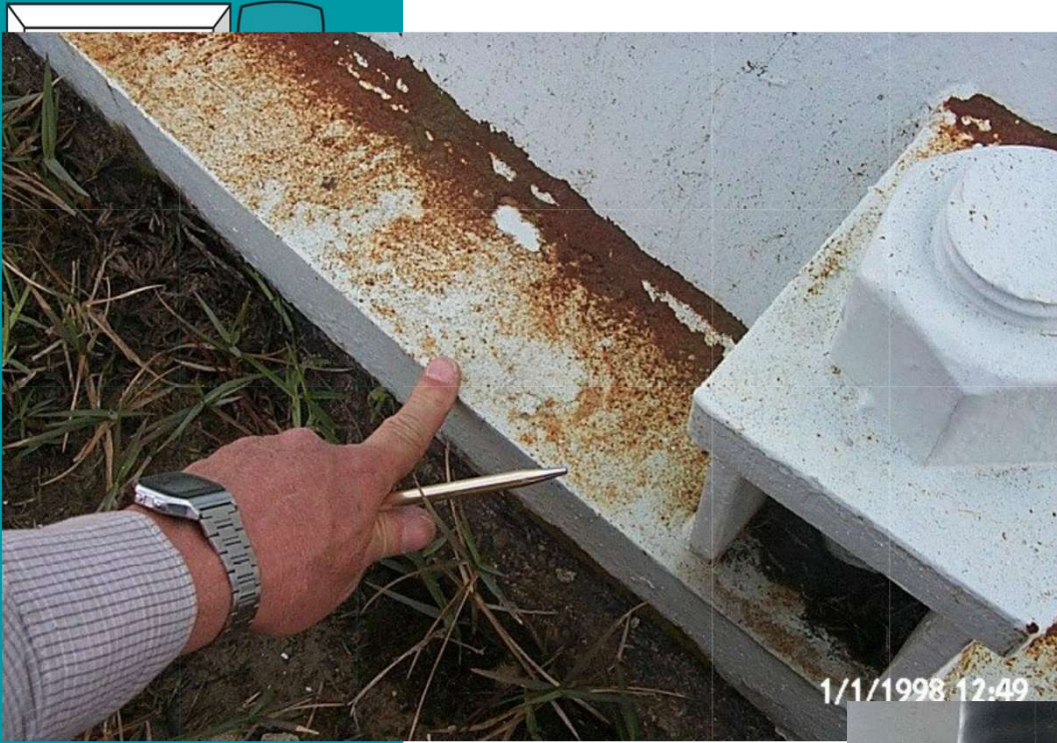
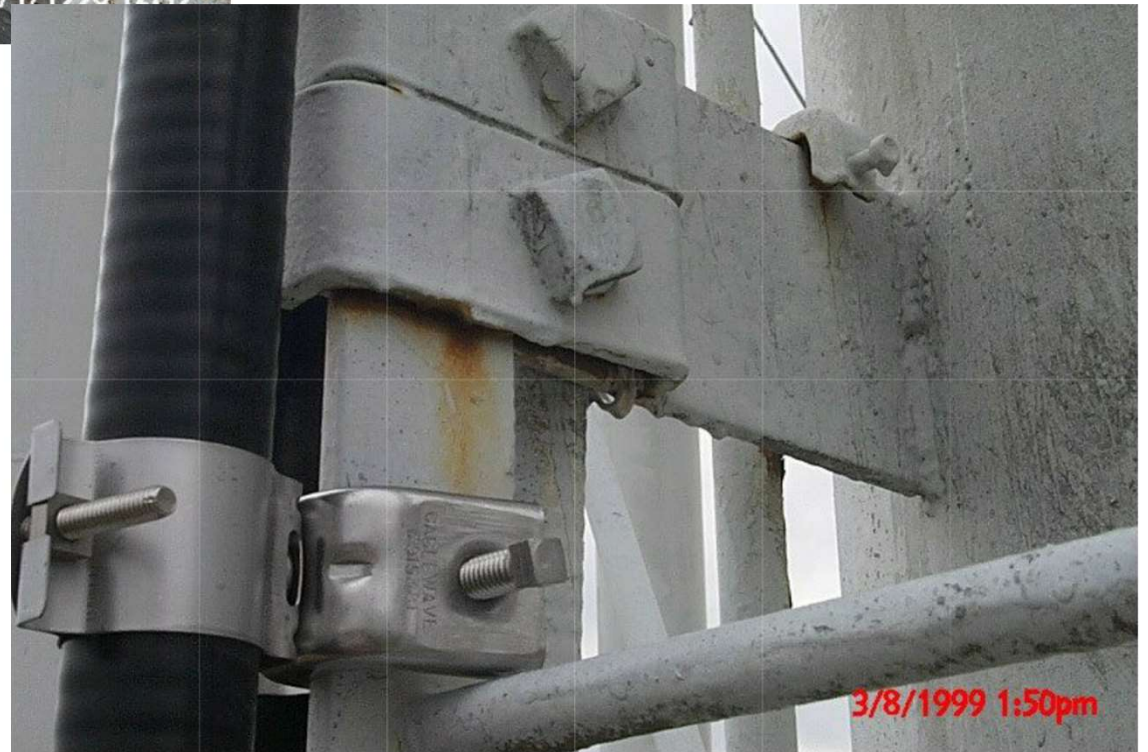
# WELDING SLAG FROM INSTALLATION

## CLIMBING HAZARD

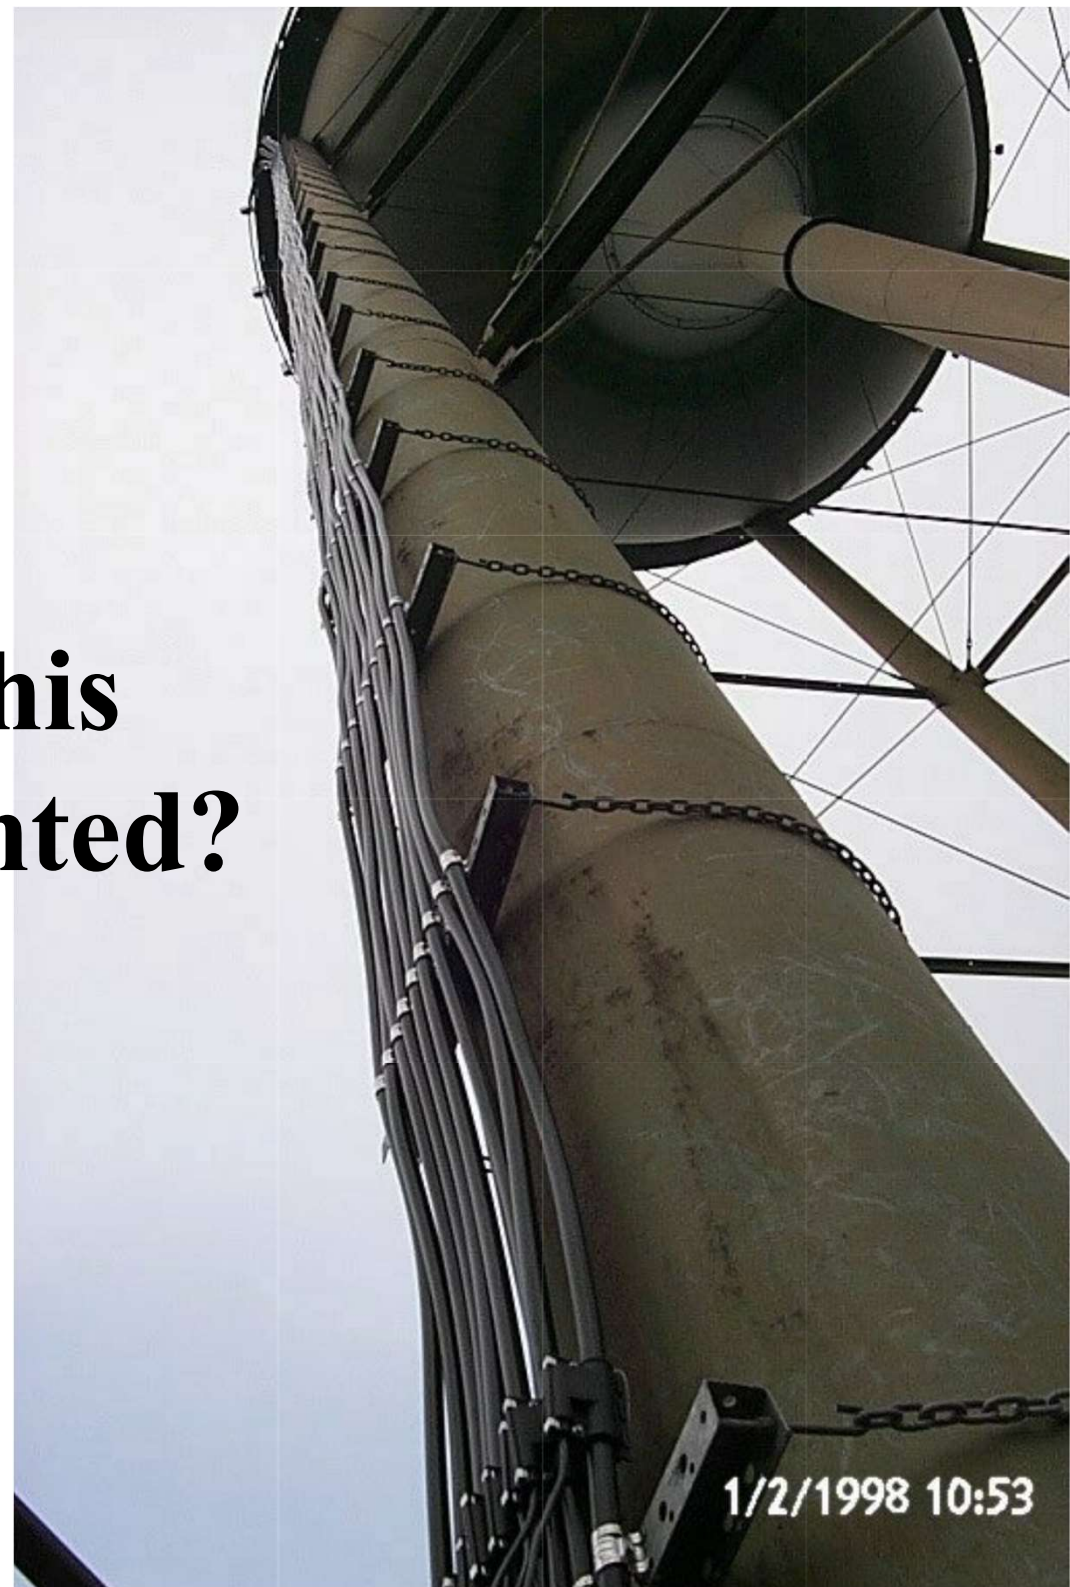
# How Can this Leg be Painted?

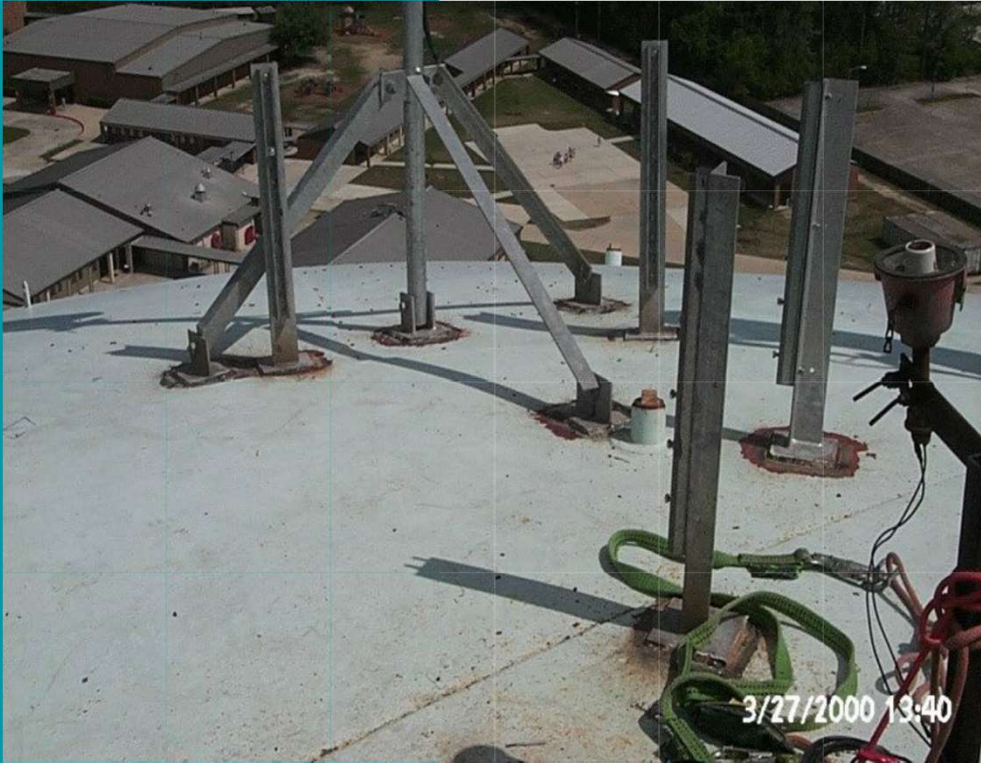
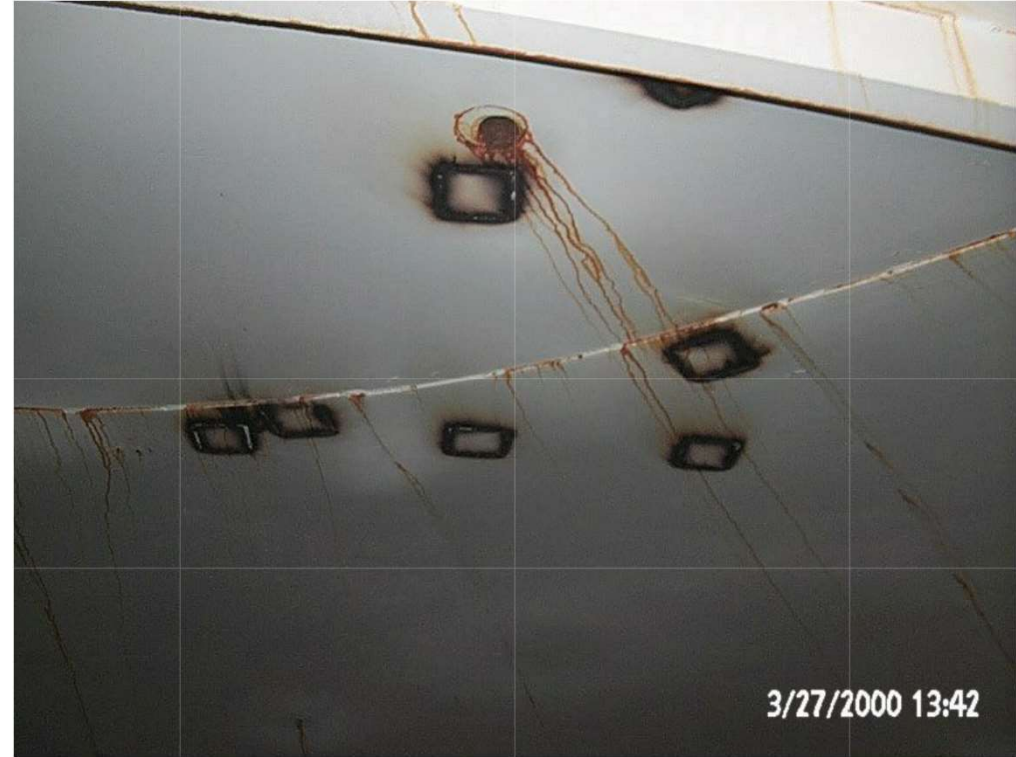
# INTERIOR & EXTERIOR COATING DAMAGE

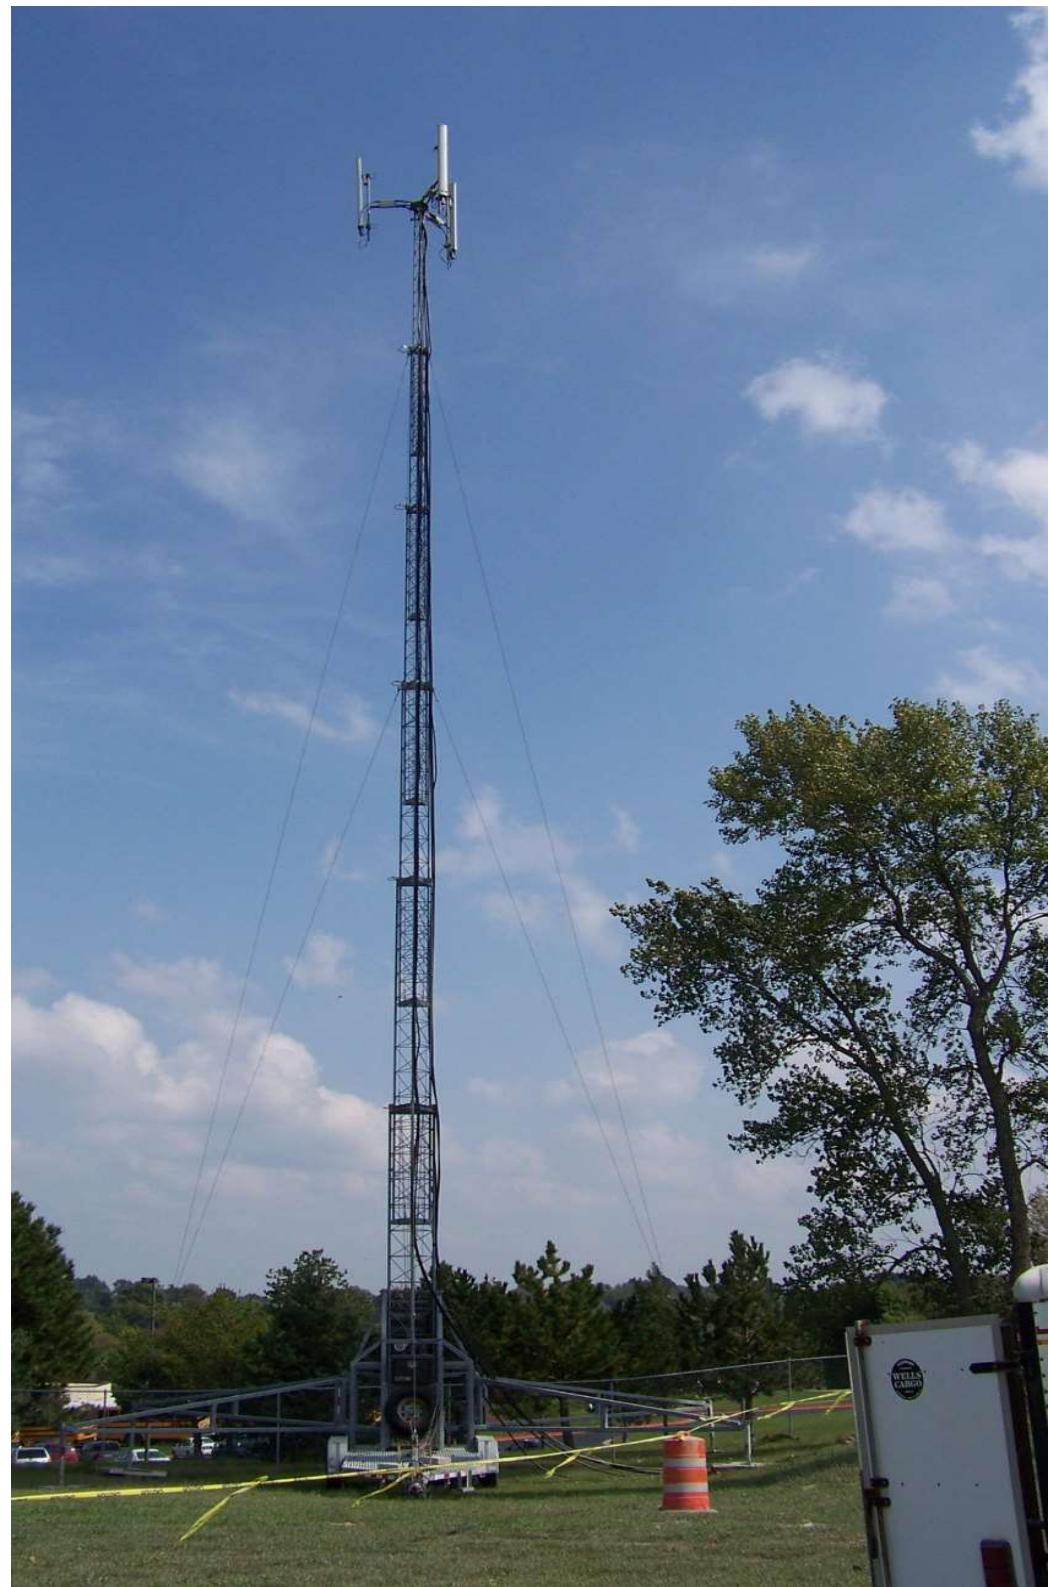
# Antenna Cow
