**Maguire Iron, Inc.**

# MANAGING ANTENNAS ON WATER TOWERS

# Antennas on Water Tanks

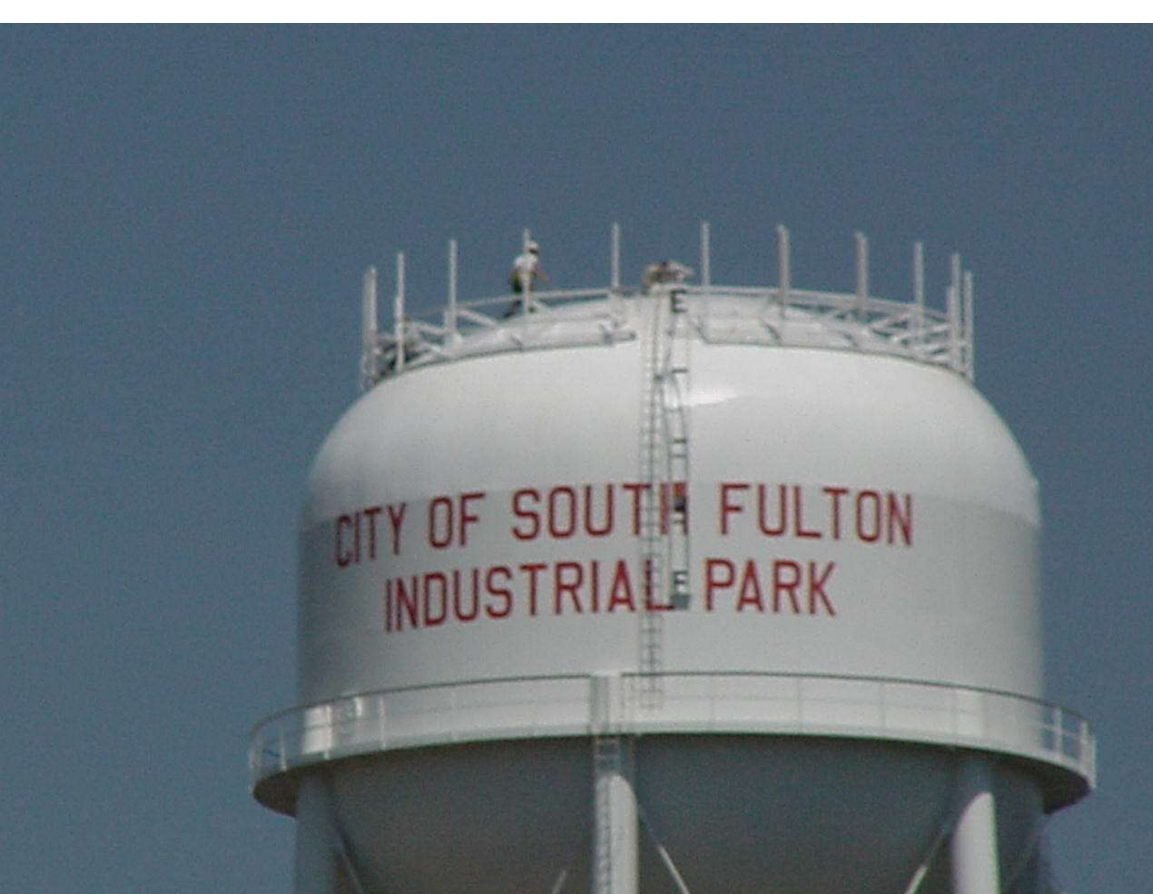
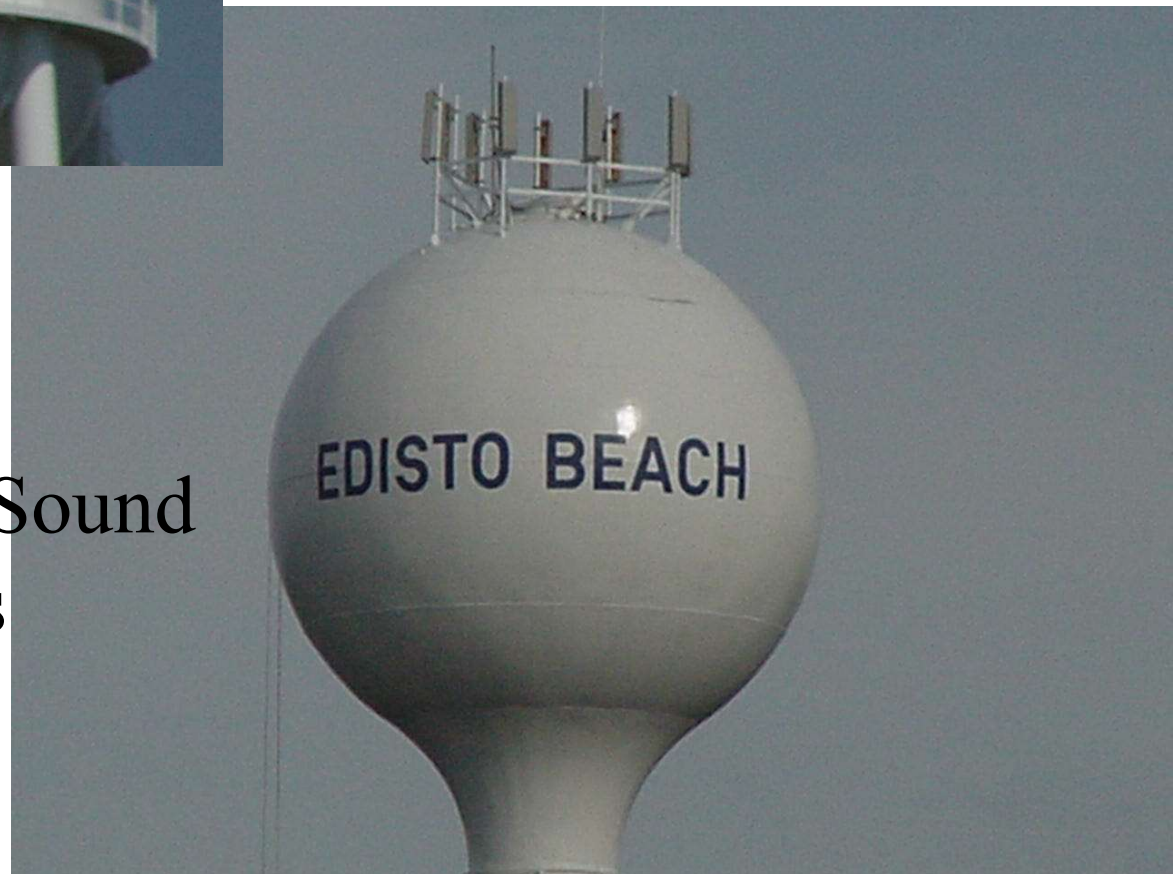
# **NEAT and PROPER ANTENNA INSTALLATIONS**

Clean & Attractive  
Installations

Structurally Sound  
Designs

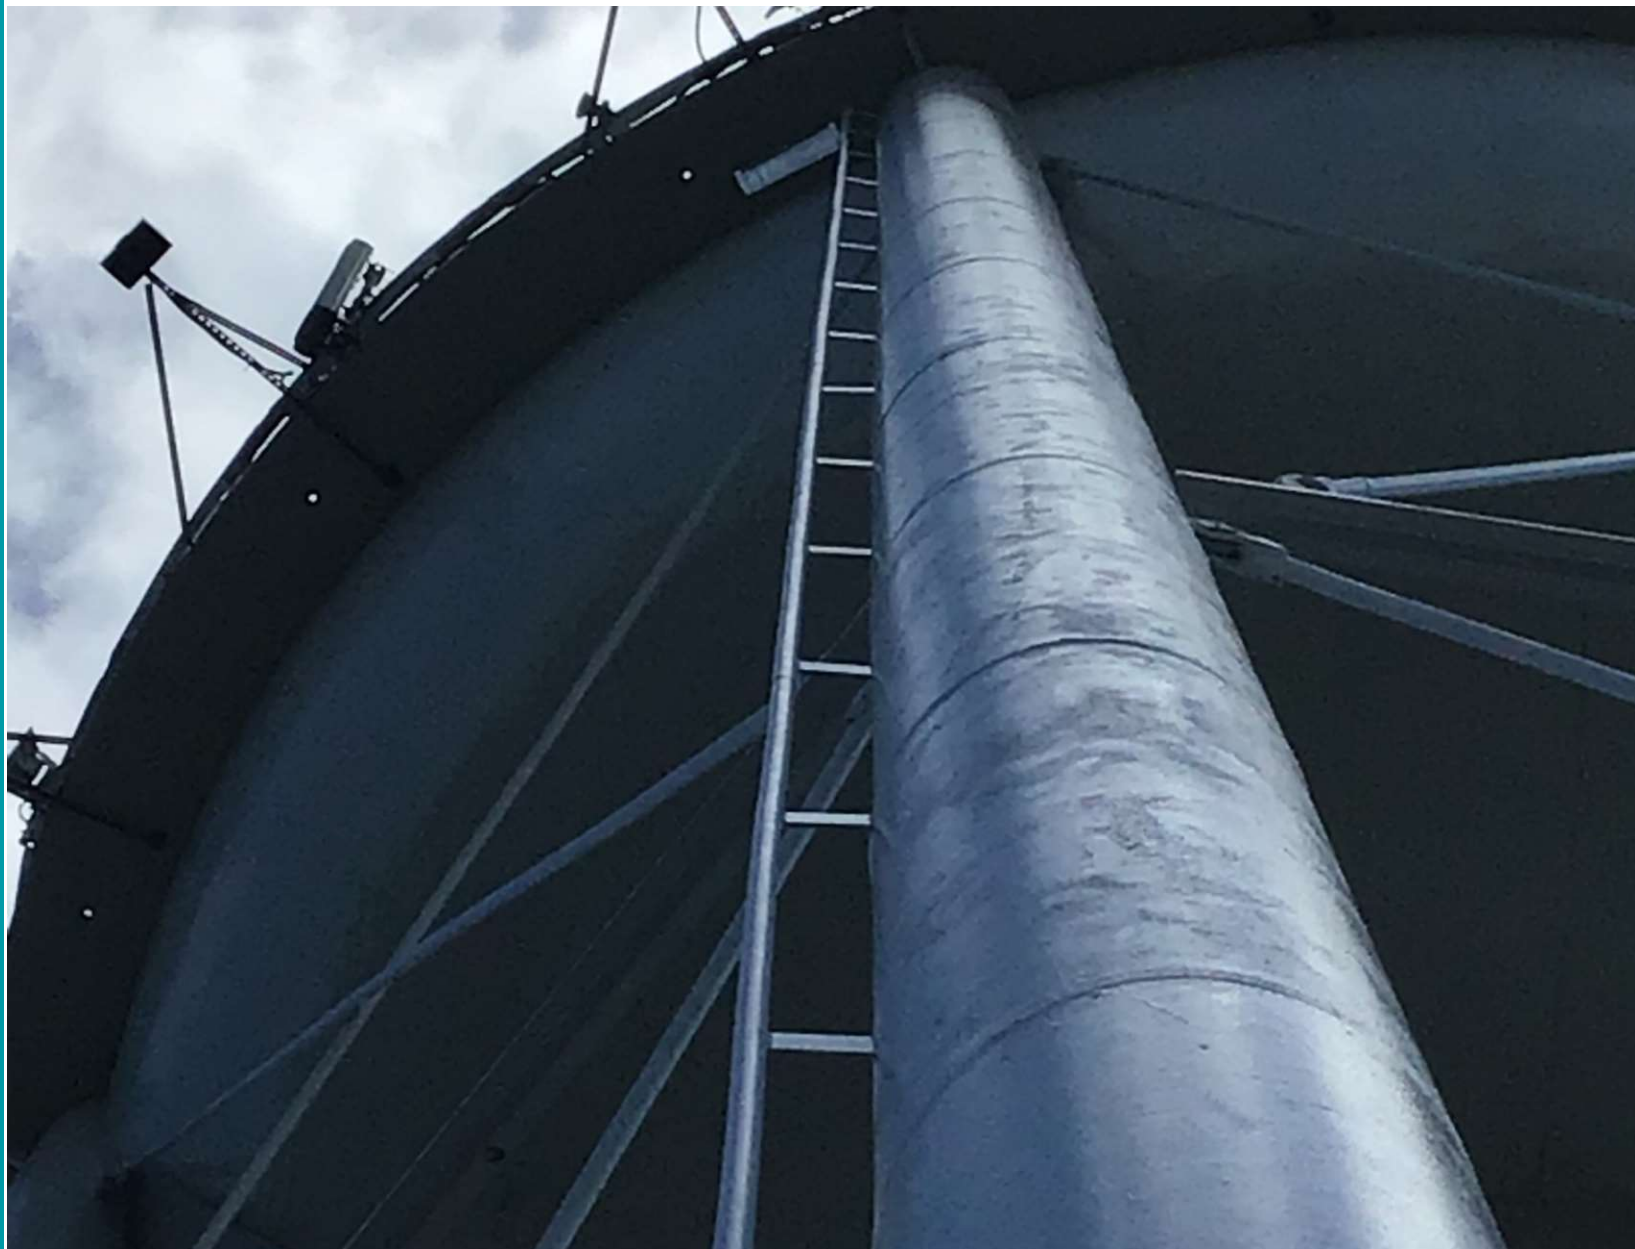
# MESSENGER PIPE

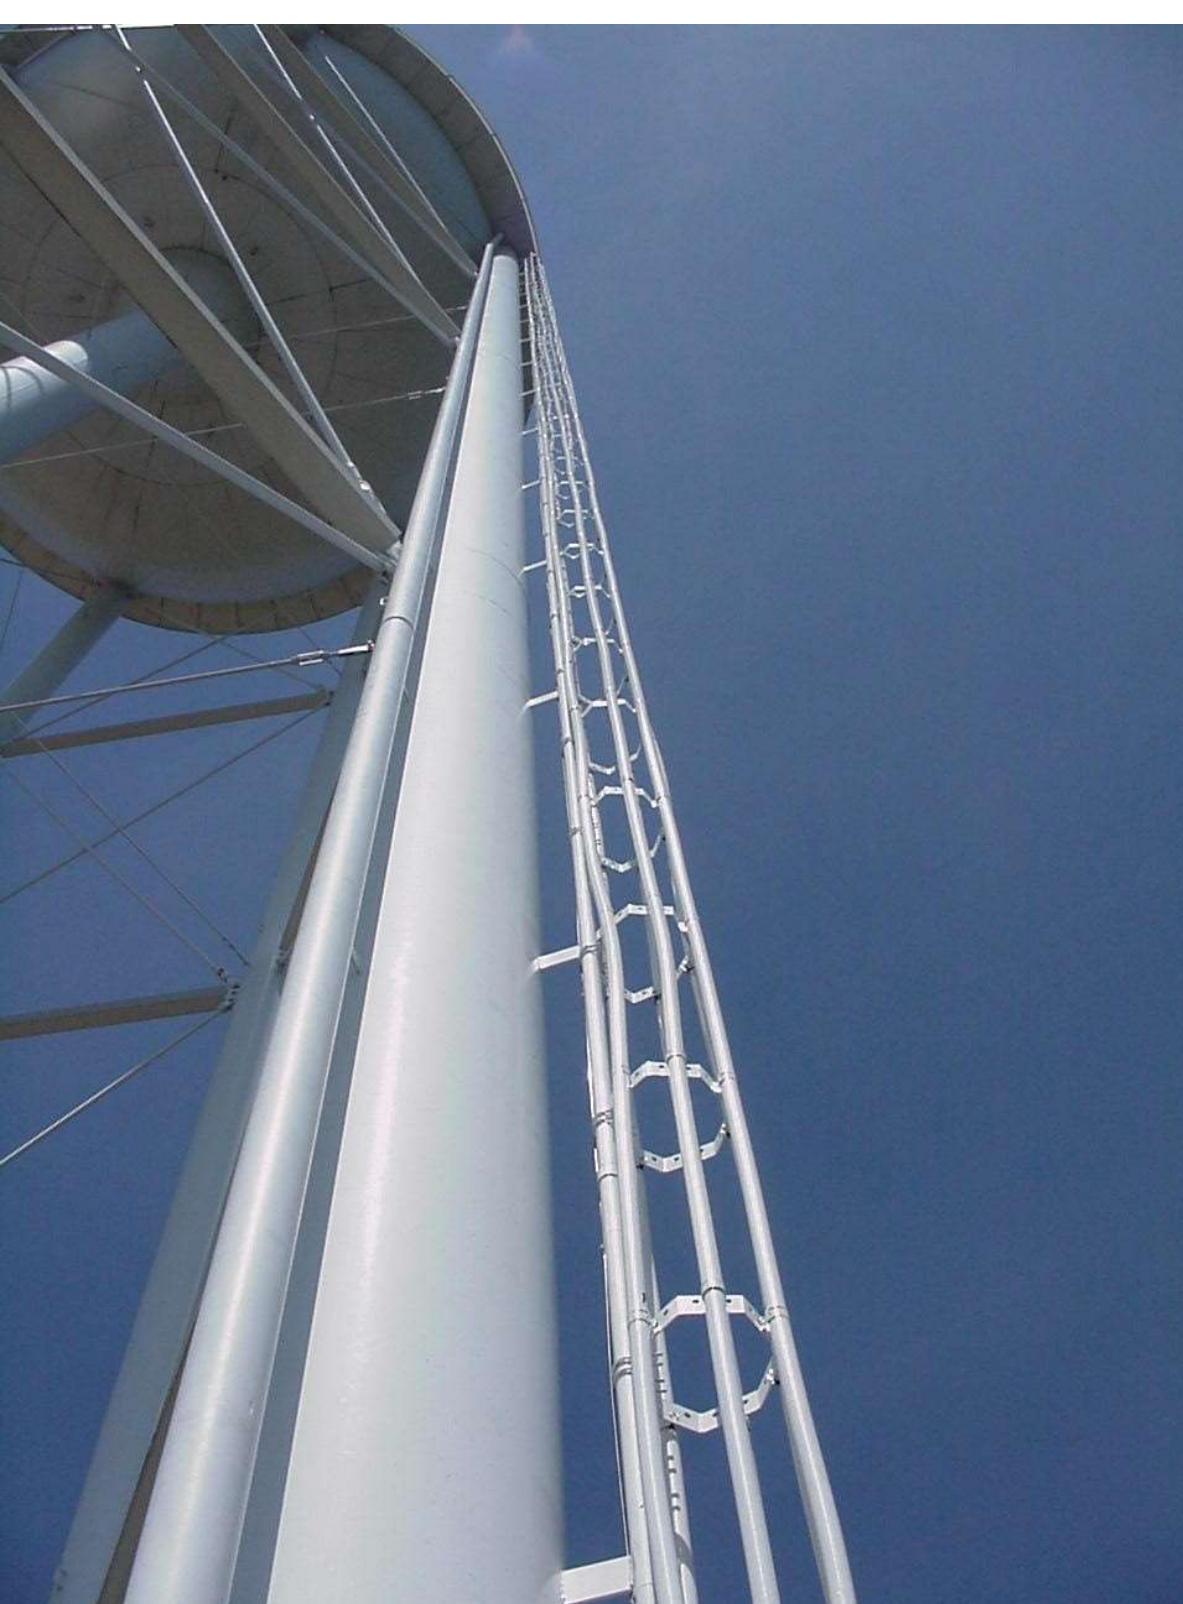
# Easier to Maintain Structure And Attachments

White Coax Cables  
match the white tower

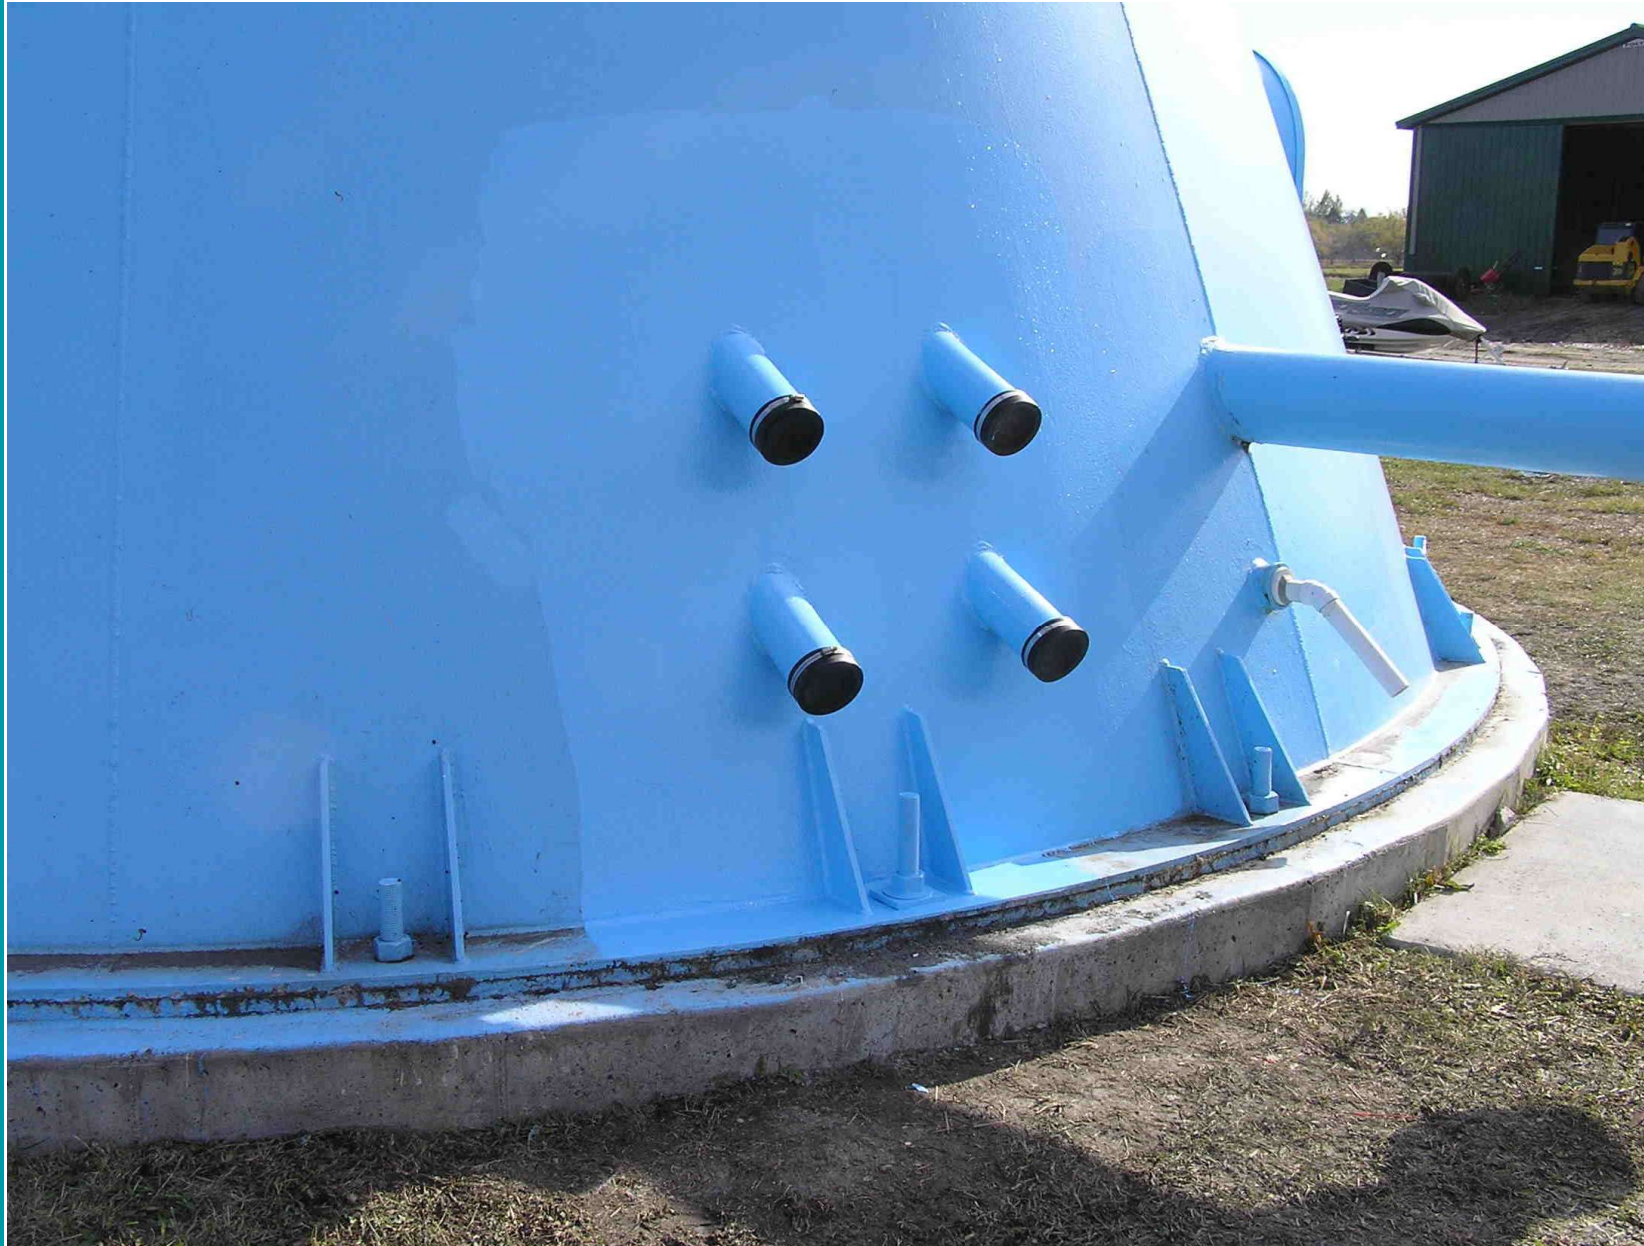
# PENETRATIONS

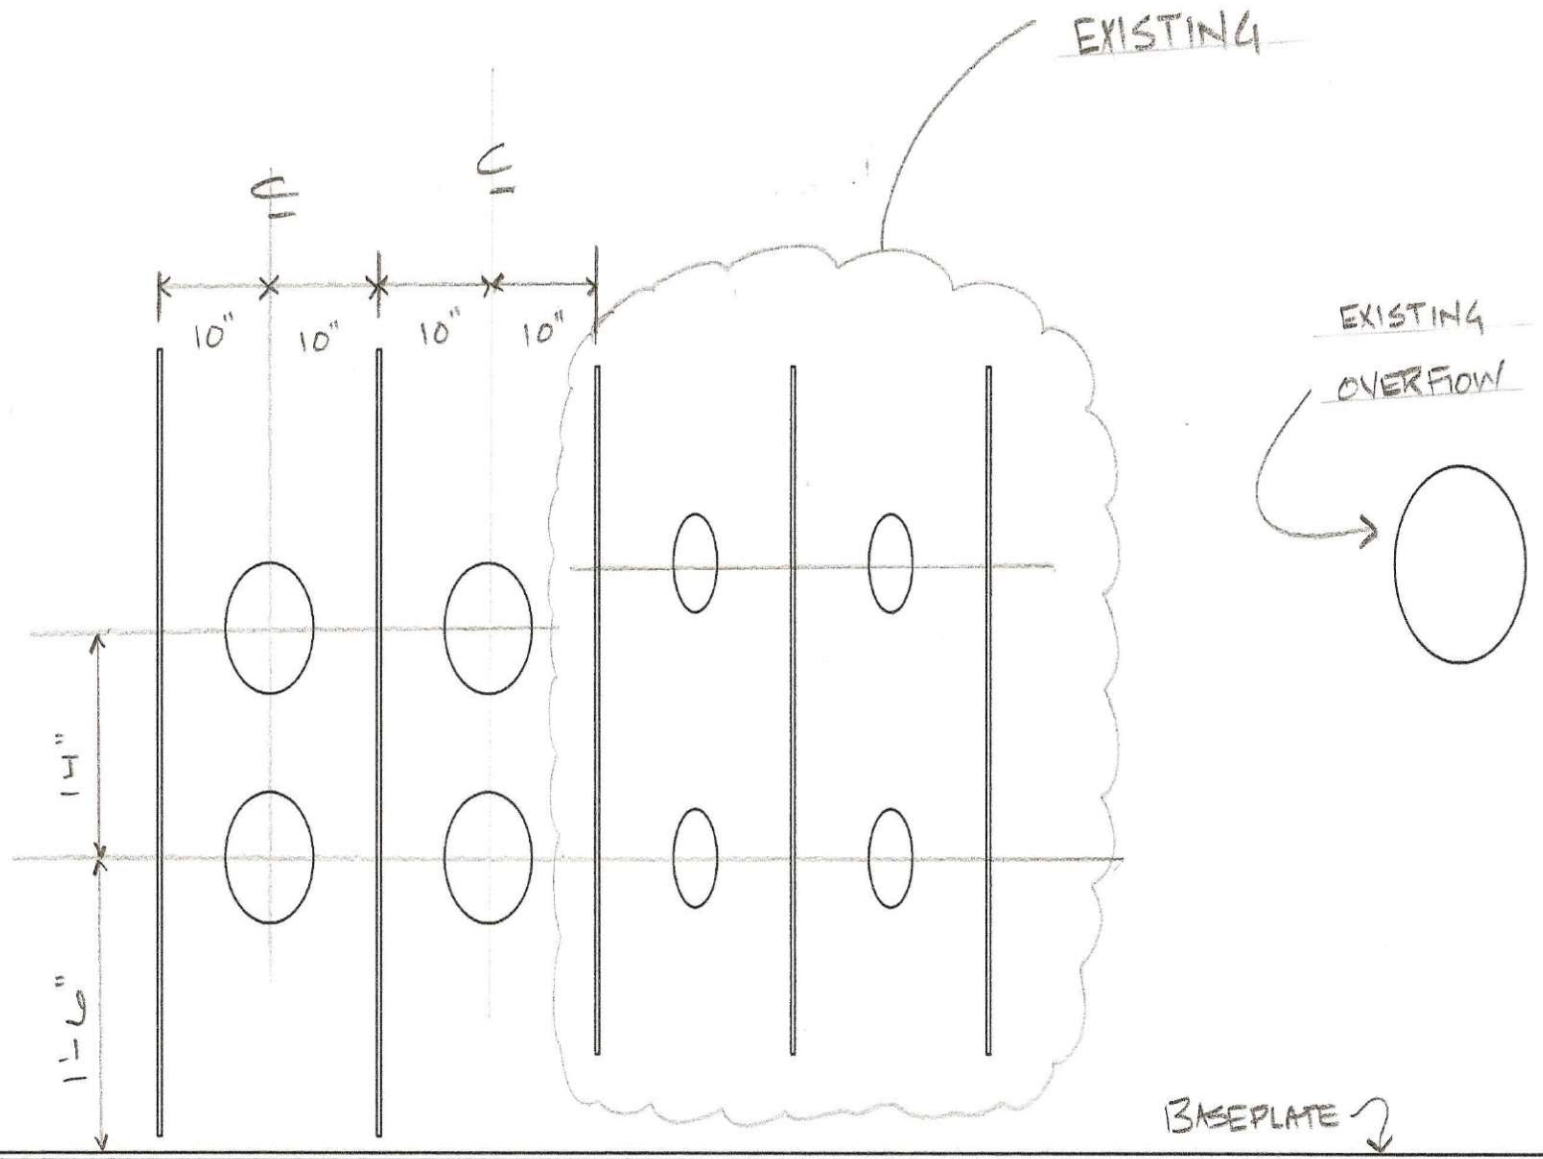
ELEVATION

OAKPORT, MN  
PENETRATION INSTALL  
11/29/11

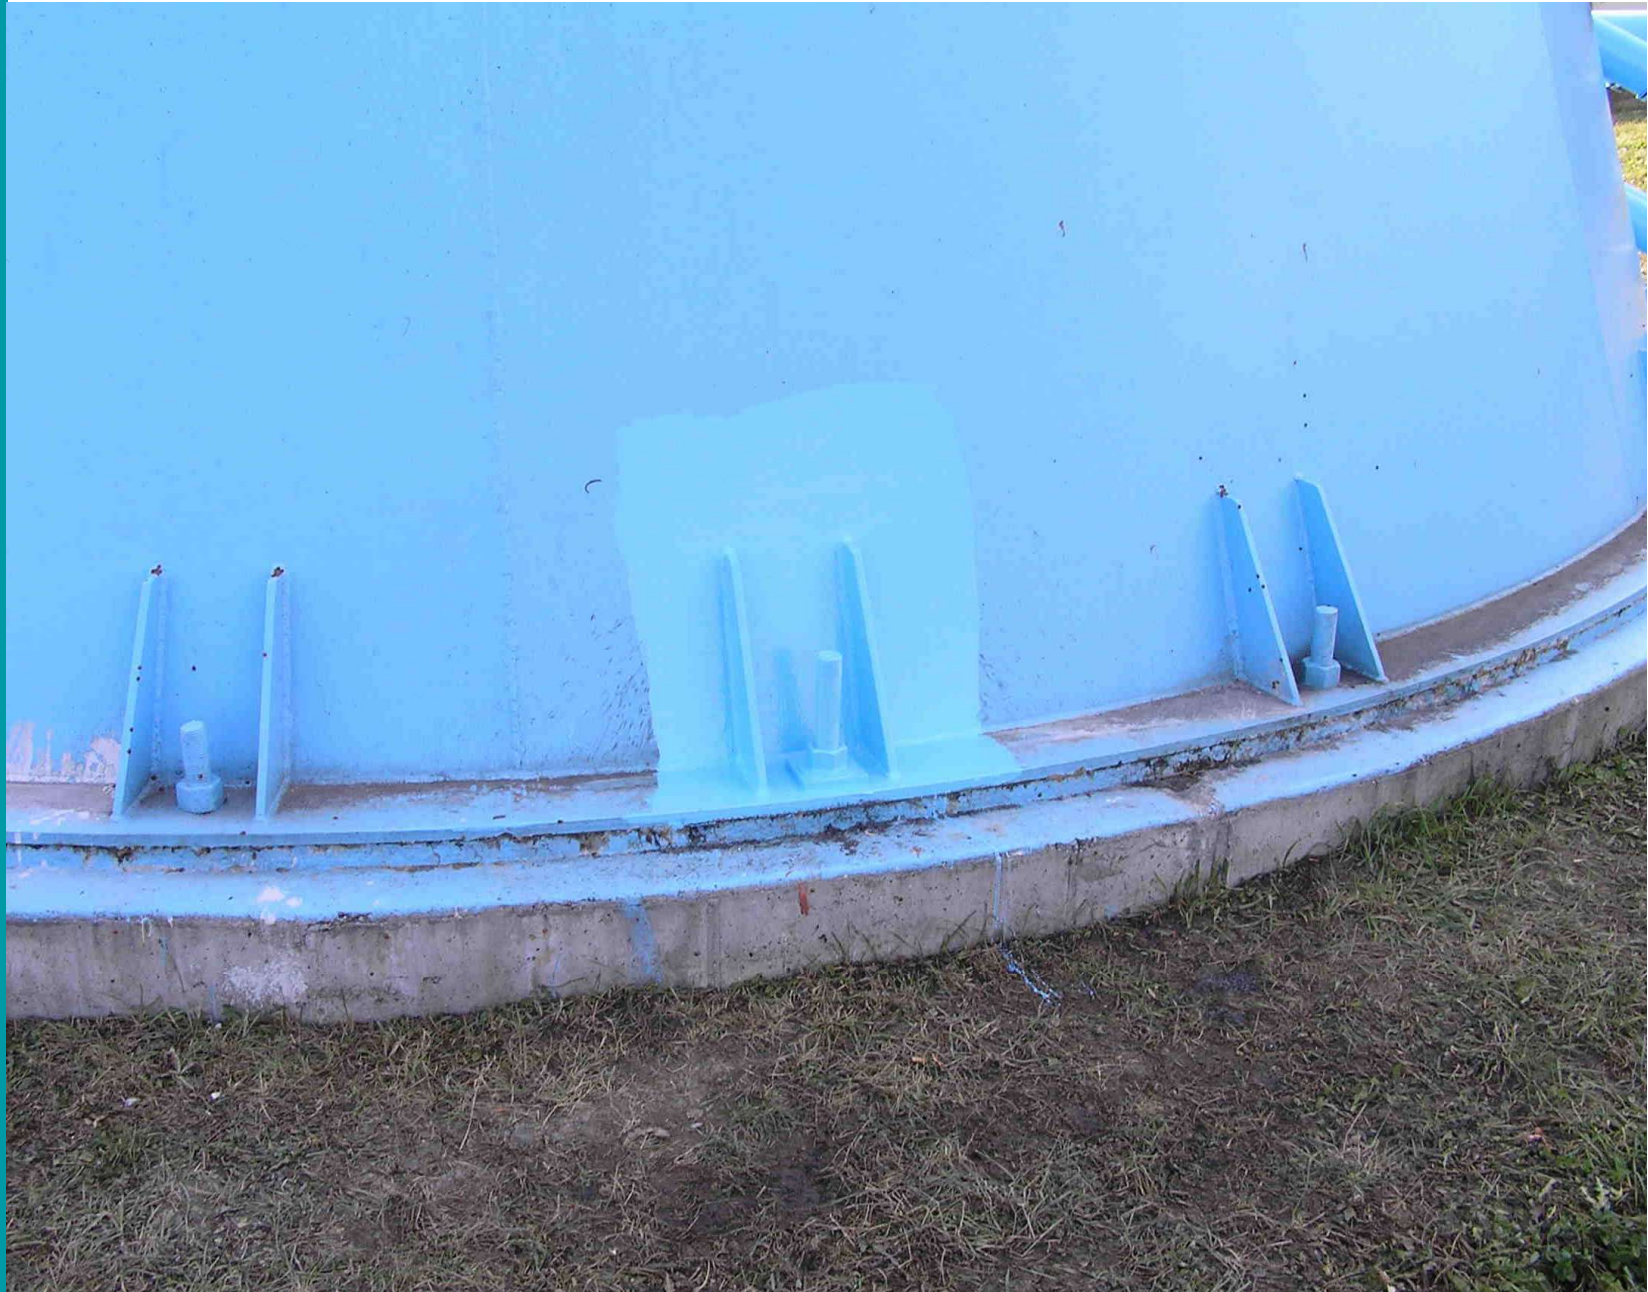
# ADDED ANCHORAGE

**Existing and Proposed Equipment - Sufficient Capacity w/ Proposed Modifications**

Member Type	Result	Pass/Fail
Modified Anchor Bolts	85.5%	Pass

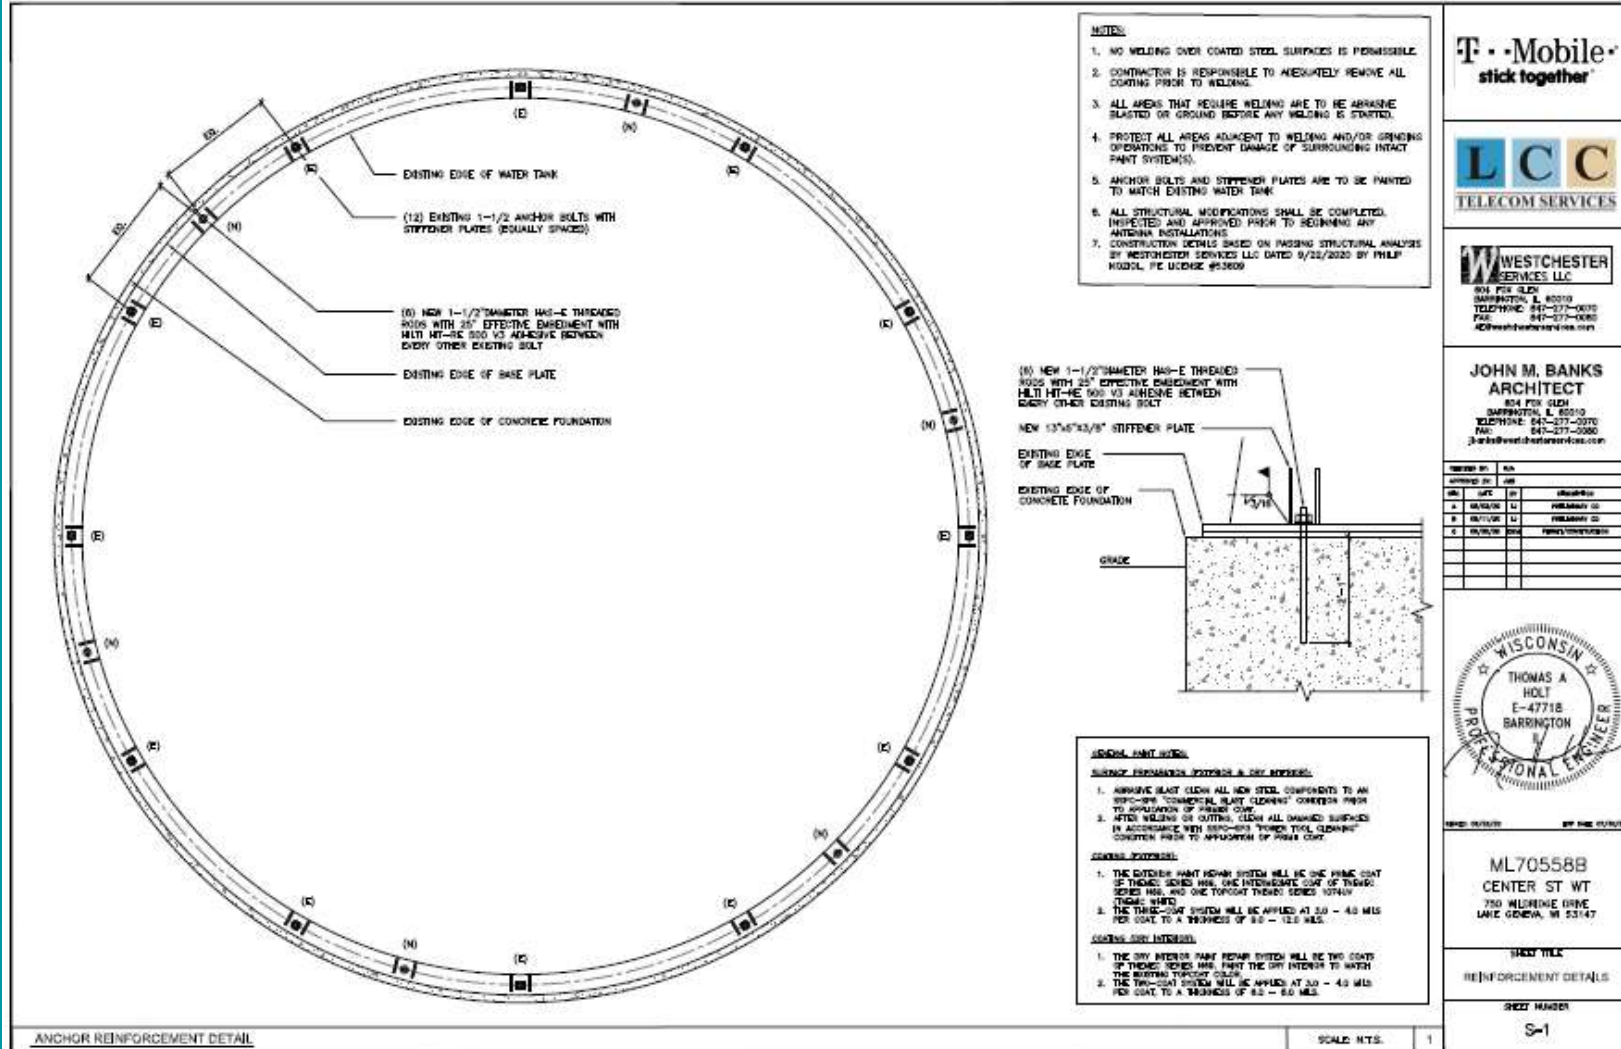
SHEET NUMBER  
S-1

REINFORCEMENT DETAILS
